Monday, January 24, 2022

Level 2, Premium Reserve Analysis

# Pawnee Hills Community Association

35644 Cheyenne Trail  
Elizabeth, CO. 80107

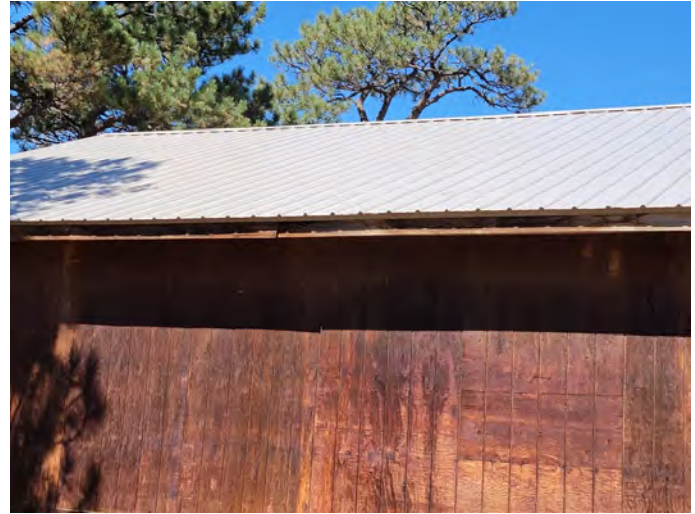
Comp #: 108 Metal Roof - Replace

- All roofs were replaced in 2015 with the same material. No reported problems with roofs or leaking.
- Roofs should be inspected at least every 2 years to ensure seams and screw holes are caulked properly and there are no areas where water intrusion can occur.
- The main concern for damage is from dents and dings as a result of hail.
- If severe damage due to a hailstorm occurs, replacement would be handled as a separate expense from Reserves
- We recommend planning on replacement every 40 - 50 years under normal conditions.

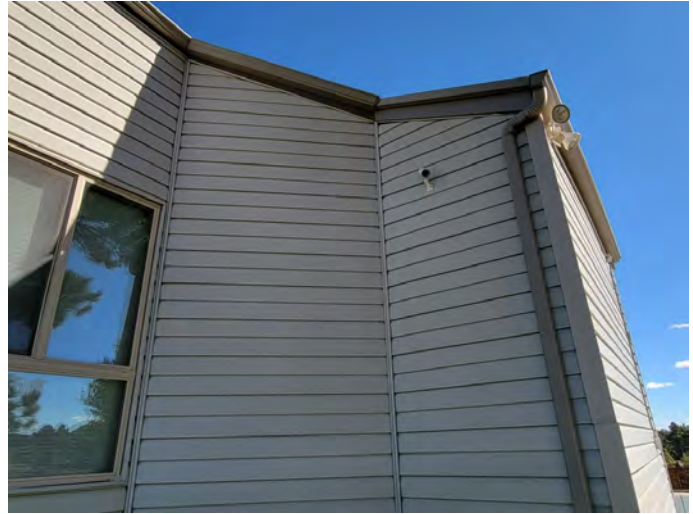
Comp #: 120 Rain gutters/Downspouts - Replace

- The average life expectancy for gutter lines ranges between 20 - 25 years depending on the quality of the materials. It is typical to replace at same time as roofing materials for best drainage results.
- Since the roof has an extended life expectancy, we recommend planning on replacement every 25 years, which is half of the roof replacement cycle.
- Lines should be cleaned out at least twice a year to prevent clogging of lines and moisture retention that will cause premature deterioration.

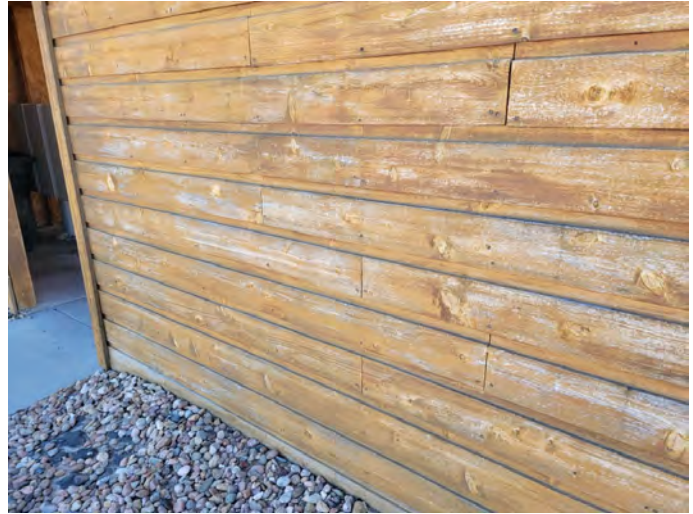
Comp #: 202 Wood Surfaces - Restain

- Surfaces are dry and wood materials are exposed to elements.
- Stain these surfaces approximately every 4 to 5 years to maintain appearance and protect wood.
- Remaining life based on current age and condition.

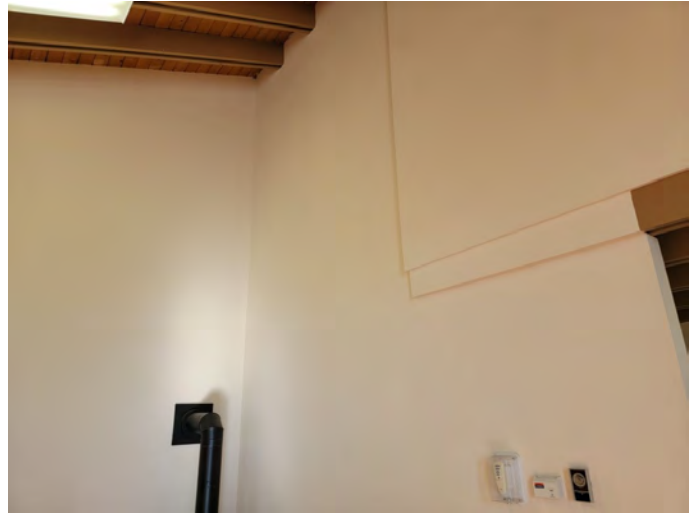
Comp #: 216 Interior Surfaces - Repaint

- Last reported painting was in 2013
- We recommend reserving to repaint the interior spaces every 8 - 12 years to maintain appearance.
- Outside of this painting cycle, damage to the surfaces and touch-up work should be performed annually with operating funds.

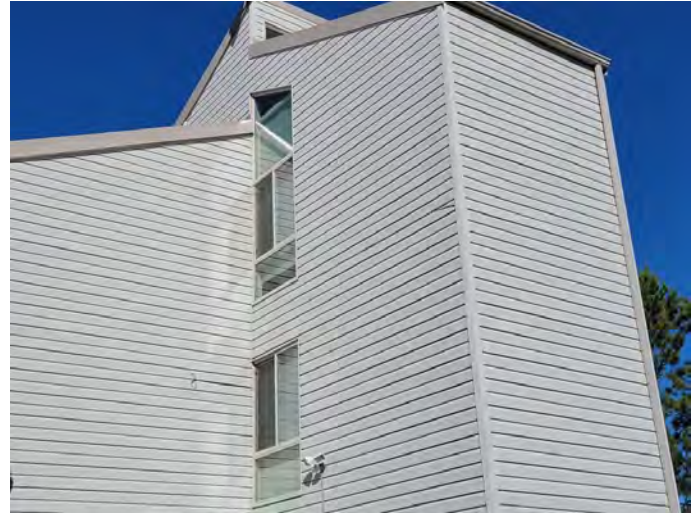
Comp #: 302 Vinyl Siding - Replace

- Several sections of slipped and loose siding was noted. While there has been some conversation to replacing the siding, there are no plans to replace it in near future.
- We suggest power washing the siding every 3 - 5 years, depending on the effects from elements.
- In our experience, we have seen the need to replace vinyl siding every 25 - 30 years to maintain an appropriate appearance for the community.
- The remaining life is based on observed conditions and age of material. While there are no current plans for replacement, the association should be financially prepared for when replacement is needed

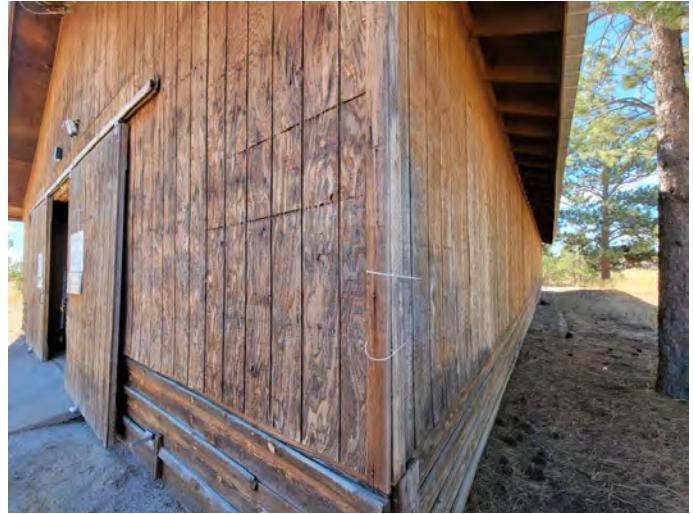
Comp #: 305 Wood Siding - Replace

- Wood siding materials are weathered and old. Holes were noted in the barn siding, which is expected for an older building
- While the wood siding has an authentic appearance and is appropriate for the area, we recommend the association have funds available in the Reserve account in case the board and owners have a desire to replace the material.

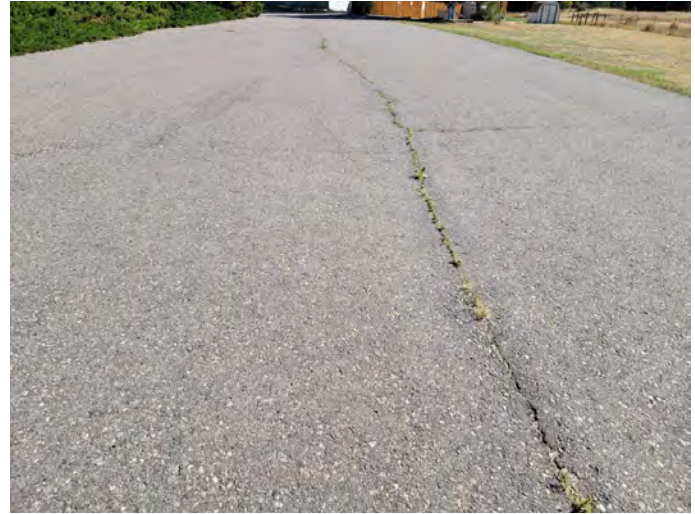
Comp #: 401 Asphalt - Major Overlay

- Parking lot was installed (paved) in 2015 and is in good condition. There are some cracks that are starting to develop and the surface is dry and oxidized.
- The average life expectancy for asphalt surfaces ranges between 20 - 27 years for surfaces that are maintained on a regular schedule.
- Maintenance includes crack fill and repairing small potholes annually as an operating expense.
- In addition, asphalt should be seal coated every 3 - 5 years, depending on the level of traffic and snow removing techniques.

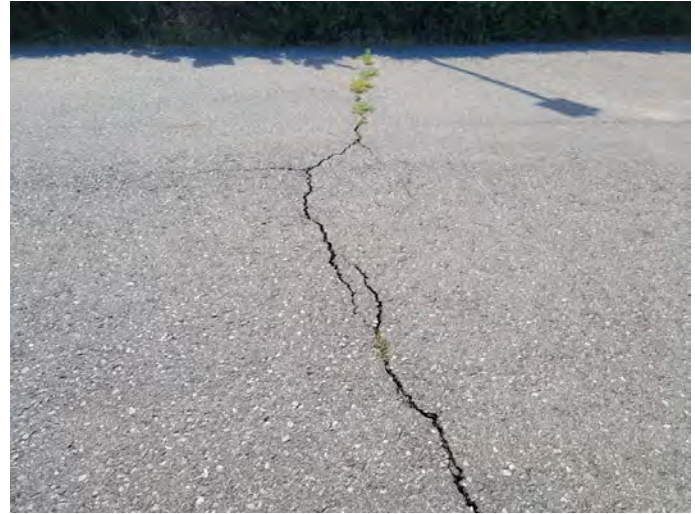
Comp #: 402 Asphalt - Surface Application

- Once asphalt is overlaid, industry professionals recommend a seal coat to maximize life of asphalt.
- Surface treatments are used to extend the useful life of asphalt and to help maintain aesthetics; there are a broad range of products to choose from so we recommend consulting a reputable contractor for your community's needs.
- The recommendation is an allowance for the mid range surface treatments that are available in today's market.
- Expect to seal coat or slurry seal your asphalt every 4 - 5 years, as the asphalt ages it may be necessary to adjust the frequency and or cost of these projects.

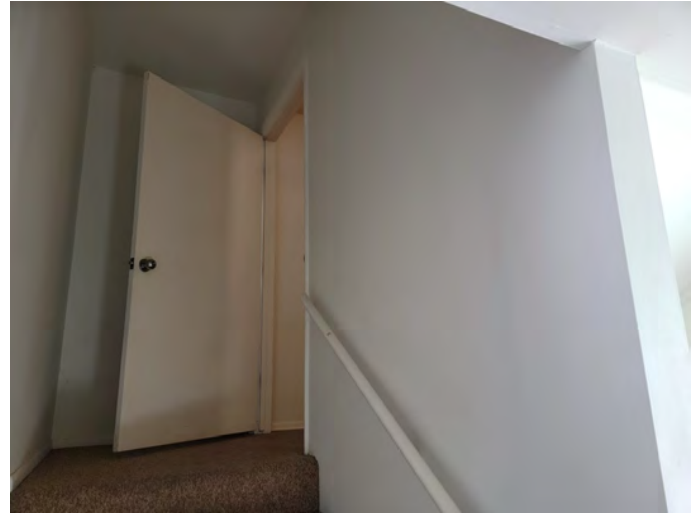
Comp #: 501 Doors - Replace

- No unusual conditions noted during site visit. It was reported the exterior doors were replaced in 2014
- Expect a useful life of 20 - 25 years from clubhouse doors if properly maintained and under normal conditions.

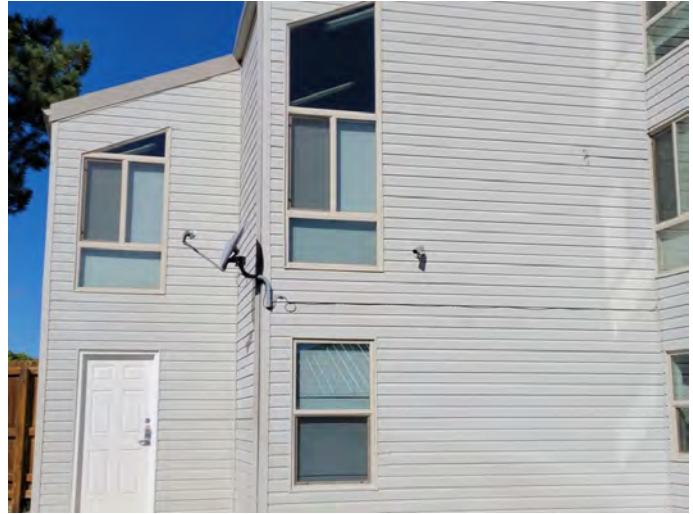
Comp #: 506 Windows - Replace

- Windows replaced in 2016. Two of the windows were broken as a result of vandalism. Will be replaced
- In our experience, we have seen the need to replace common area windows and doors every 25 - 30 years on average.

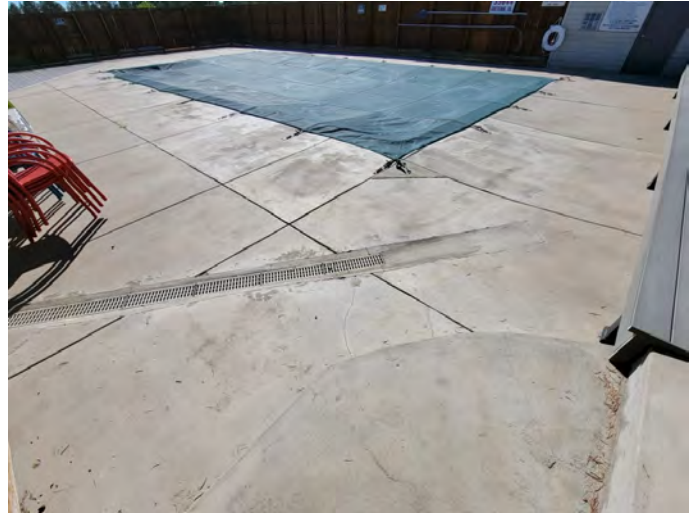
Comp #: 601 Concrete Sidewalks/Decks - Repair

- It is unlikely all areas will fail and need to be replaced at the same time.
- Therefore, we set an allowance of 15% of the total area (500 GSF) every 5 years.
- As the property continues to age, it is possible the percentage or frequency of repairs will need to be adjusted in future Reserve Study updates.

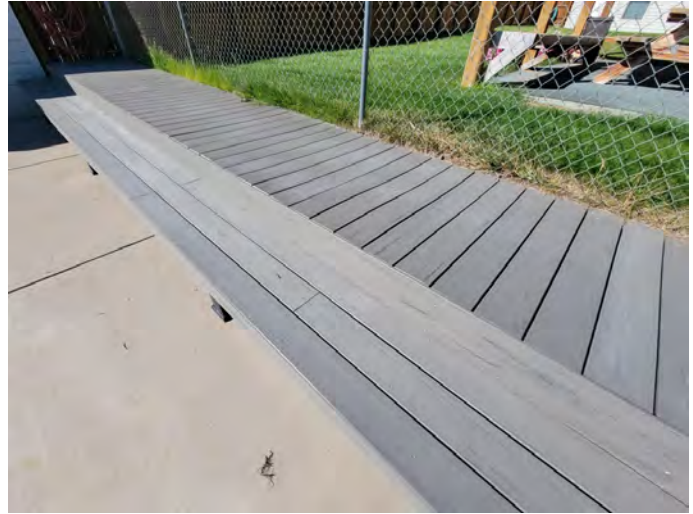
Comp #: 609 Composite Deck - Replace

- Most composite deck manufacturers offer a 25 year limited warranty from against defects.
- However, over a period of time, the material begins to fade and scratch and eventually will become aesthetically unpleasing.
- Therefore, due to the level of use and exposure to the elements, we recommend establishing a replacement cycle of 20 - 25 years.

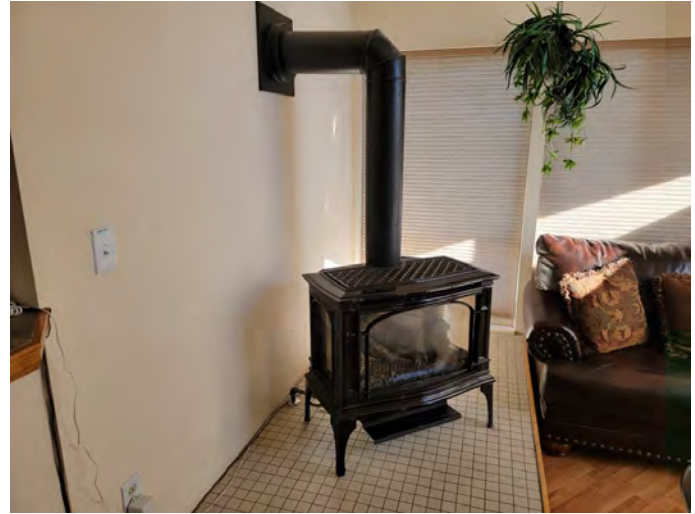
Comp #: 701 Gas Stoves - Replace

- Stoves were installed in 2016 and are in good condition with no reported problems.
- According to the manufacturer, the average life expectancy for these units ranges from 20 - 25 years under normal conditions.
- Assuming these units are not used frequently, like one would be used in a home, expect to replace every 25 years at this time. Life expectancy can be changed in future updates if necessary.

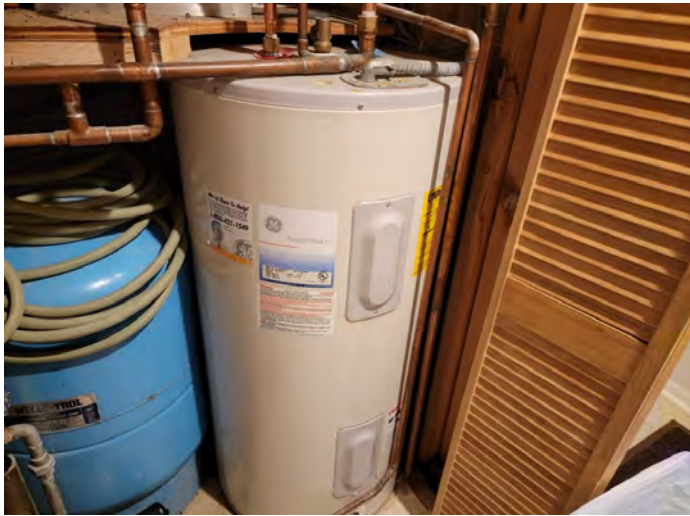
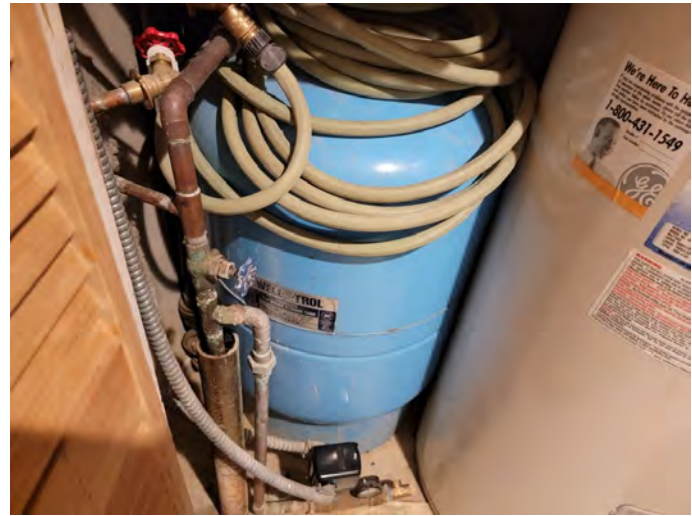
Comp #: 703 Water Heater & Expansion Tank - Replace

- It was reported the pressure valve on the expansion tank was recently replaced
- While we understand this water heater is run minimally through year, the average replacement cycle for these heaters typically ranges between 12 - 15 years.
- We recommend replacing when heater has reached the end of the useful life to prevent an "emergency call" from a plumber, which will more than double the replacement cost.

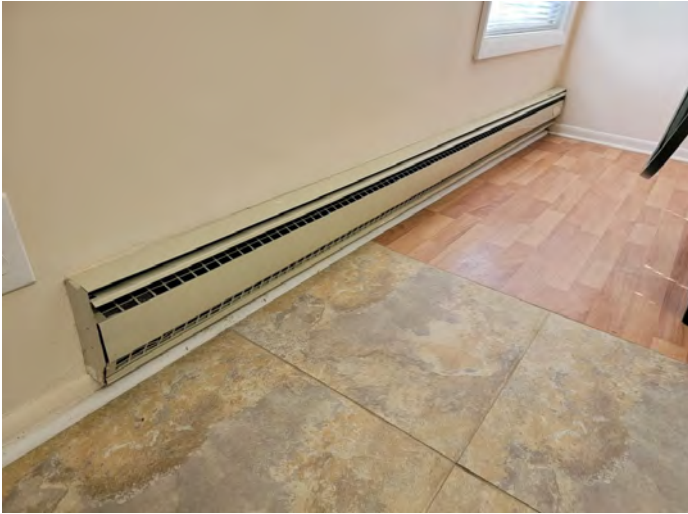
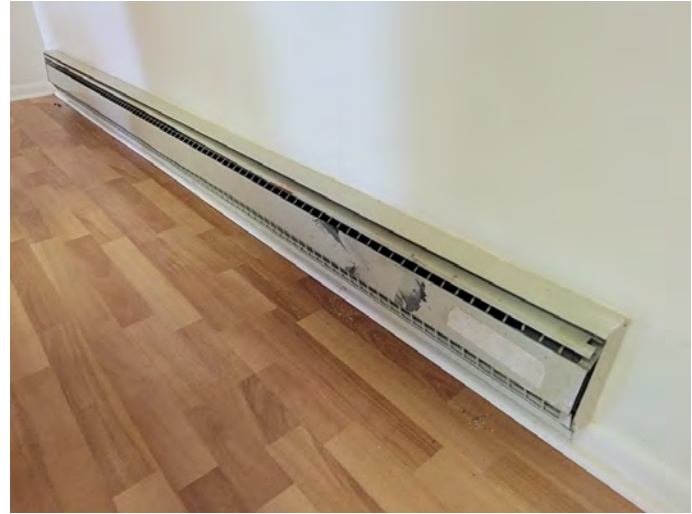
Comp #: 717 Baseboard Heaters - Replace

- BOD has been replacing these on an as needed basis using operating funds.
- Many heaters were removed when the stoves were installed.
- Due to the varying ages of baseboard heaters, Reserve funding is not necessary at this time.
- Replace on an as needed basis with general operating funds.

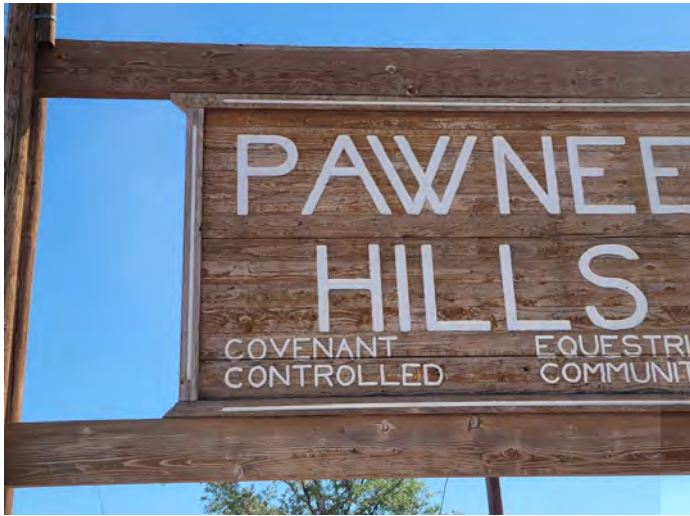
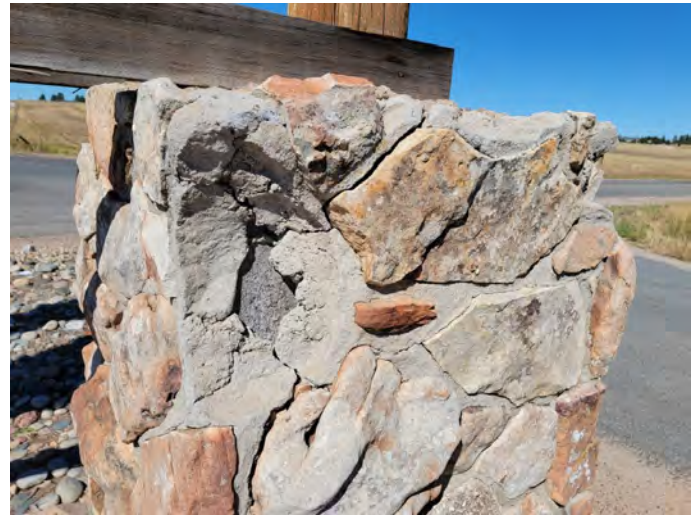
Comp #: 801 Entry Sign - Major Repairs

- Wood sign is in need to stain to enhance the appearance and to protect the wood materials from exposure to elements that may cause deterioration. We noted several loose or missing stone work as well.
- This line item is for major repairs to occur every 10 - 12 years.
- Due to the community being in a high wind area, we recommend frequently inspecting the monument and performing minor repairs on an as needed basis using operating funds.
- This line item is for periodic repairs and should not be misconstrued as complete replacement of the entire structure

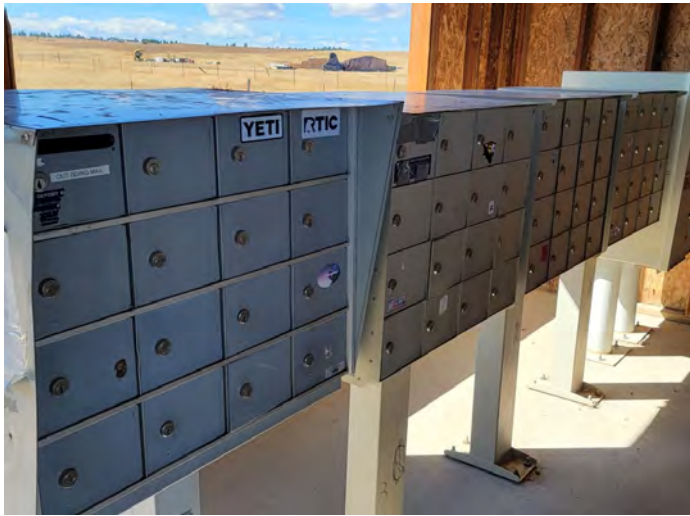
Comp #: 803 Mailboxes - Replace

- This line item is for the original mailboxes that were installed when construction of the community began.
- Per Postal regulations effective 2012, "all customers are responsible for repairs and replacement of keys, locks, or the boxes/cluster units themselves".
- Based on our experience, these boxes will have a life expectancy of 15 - 20 years due to location and quality.
- Remaining life is based on age and observed condition.
- When replacement is required, we recommend replacing with a CBU that contains parcel lockers to save money and space. Replace bulletin boards as needed with operating funds.

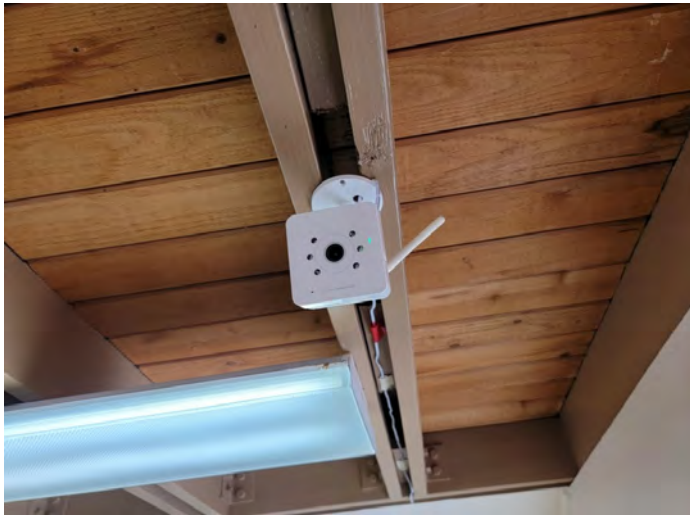
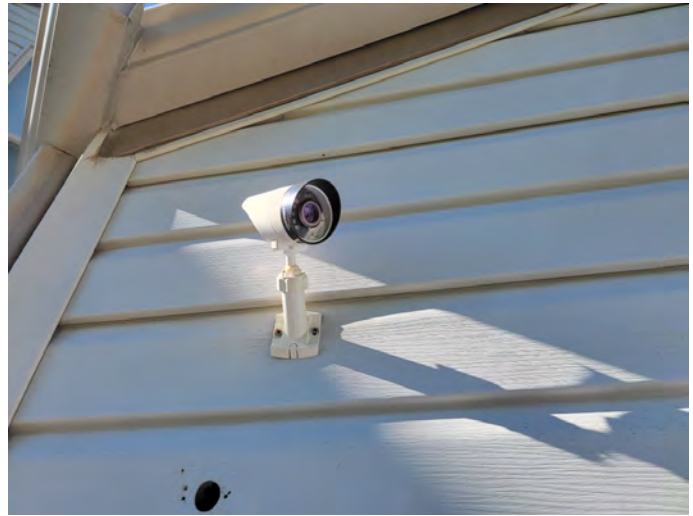
Comp #: 903 Security System - Replace

- System is reported to be approximately 7 years old and the contract is up for renewal in 2022. It is unknown at this time if the contract will be renewed or if a new system will be purchased and owned by the association.
- We recommend Reserving to replace the system and if the decision is to continue to lease a new system, then Reserve funds can be deleted from the analysis.

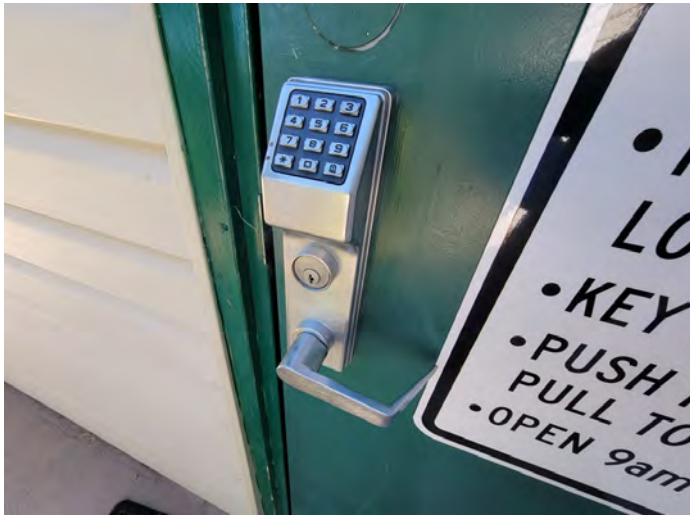
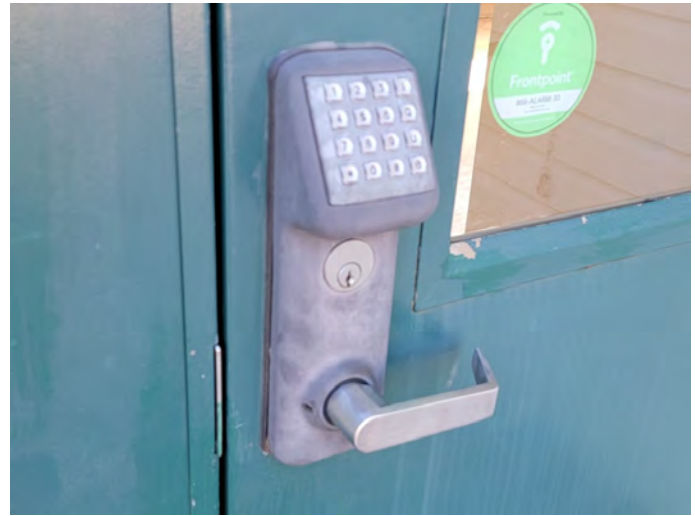
Comp #: 910 Key Card System - Replace

- It was reported the association is considering installing a key card system to prevent uninvited guests from using the pool and clubhouse areas
- Depending on the quality of the system, we typically see these systems need to be updated every 8 - 12 years due to advances in technology.
- Remaining life is based on reports of desire to install a new system

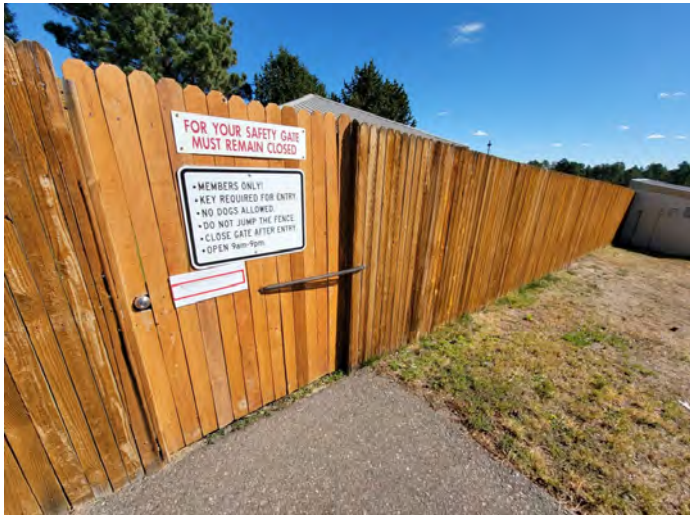
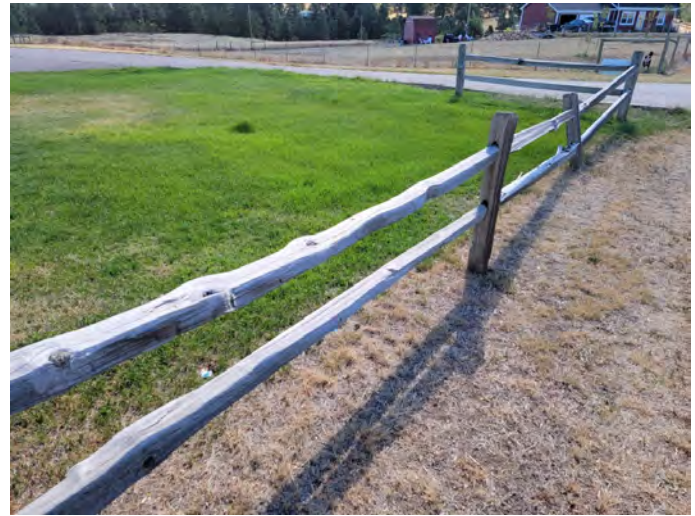
Comp #: 1001 Wood Fencing - Replace

- Approximately 110 LF of the rail fence is being replaced by on site facilities manager. This expense will be handled as an operating expense, as opposed to from Reserves
- The privacy fence has reached the end of its life expectancy and replacement is required in the near future.
- Since sections of the rail fence can be repaired/replaced as needed with operating funds, we recommend setting Reserve funds aside for the privacy fence only.
- The remaining life of the privacy fence is based on observed condition and age of materials.

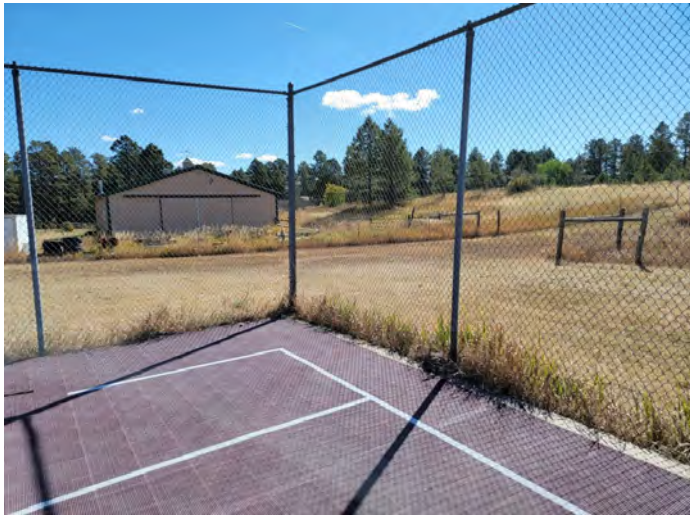
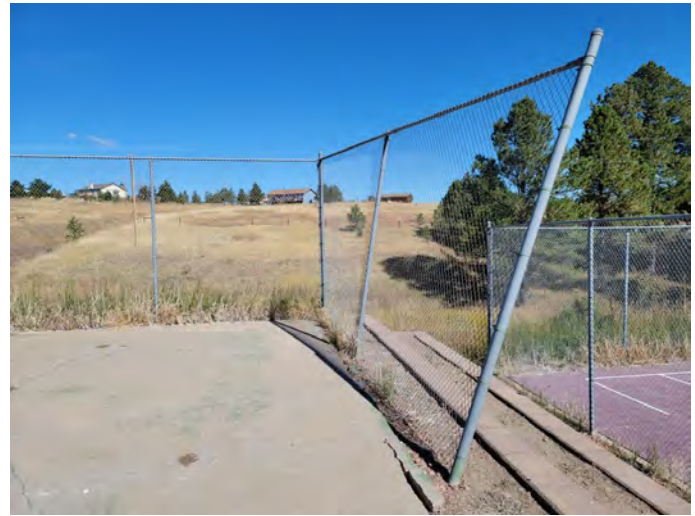
Comp #: 1003 Chain Link Fencing - Replace

- Fence around the upper court (out of commission) is in very poor condition and should be removed or replaced. Fence around sport court is in fair condition with some bent areas and loose chain link sections. Pool fence that separates the upper picnic area from the lower pool area is in good to fair condition with no major concerns noted.
- Based on observed conditions, we have added an allowance for periodic major maintenance or repairs to the fencing.
- At the very least, we recommend removing the fence from the upper court that could pose a liability concern

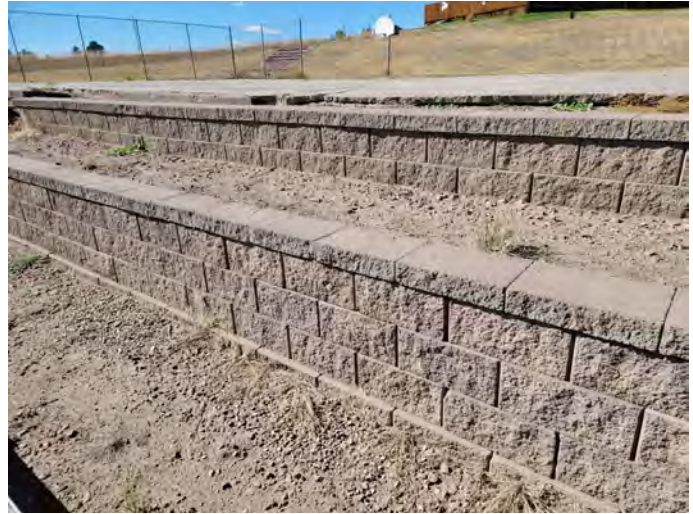
Comp #: 1005 Block Wall - Replace

- As long as block wall was installed conforming to county code requirements, this wall should have an extended useful life.
- As these walls typically have an extended useful life, if installed properly and there are no unexpected drainage or soil issues that would cause damage, we do not recommend funding for the replacement of these walls.
- If conditions change in the future, funding can be added in future Reserve Study updates for periodic repairs.

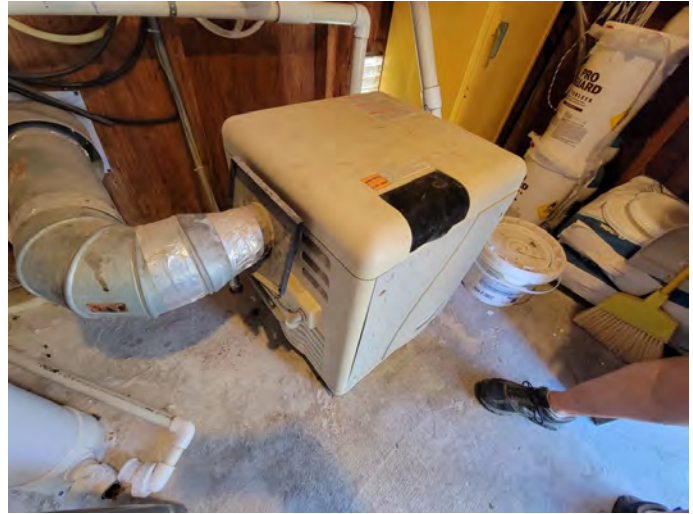
Comp #: 1104 Pool Heater - Replace

- Pool heater was replaced in 2012 and was reported to be in good working condition this past season, but heater is no longer manufactured. It was also reported this heater is a special heater due to the high winds in the area.

- Under normal conditions and depending on the quality of water running through the system, expect a useful life of 10 - 12 years from this pool heater.

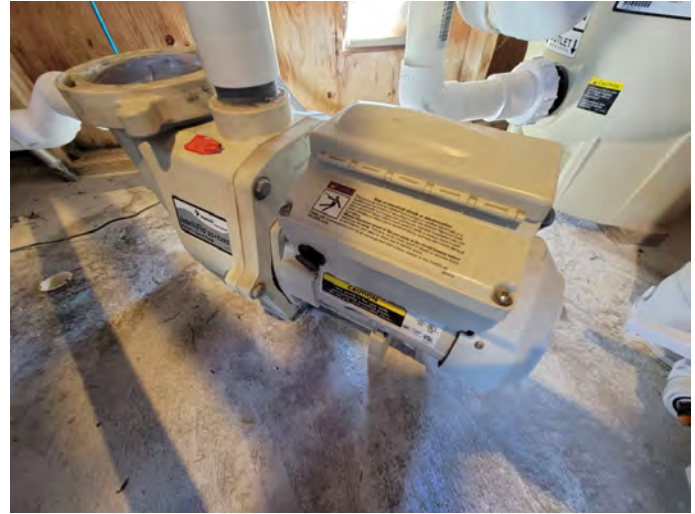
Comp #: 1112 Misc. Pool Equipment - Partial Replace

- Chlorinator was replaced in 2020 and is in good condition. Pool pump was replaced about 5 years ago and was reported to have less than a couple years left before replacement is needed.
- The individual replacement cost of these items is too small for separate Reserve designation.
- Since the life expectancies and costs vary, we suggest establishing Reserve funds for partial replacement of equipment every 7 years.

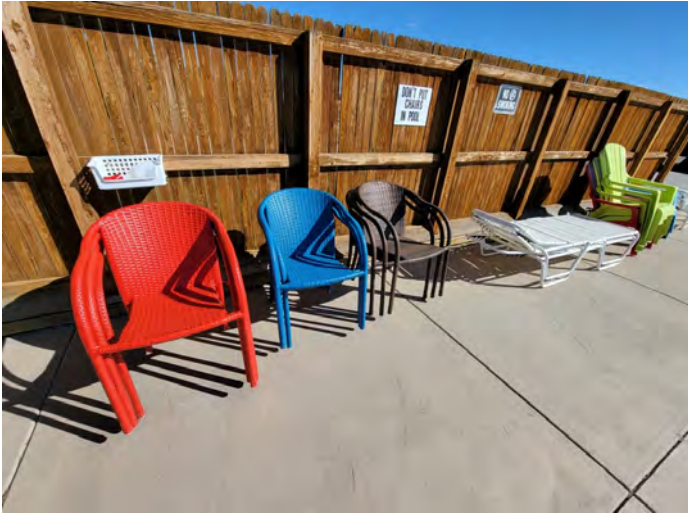
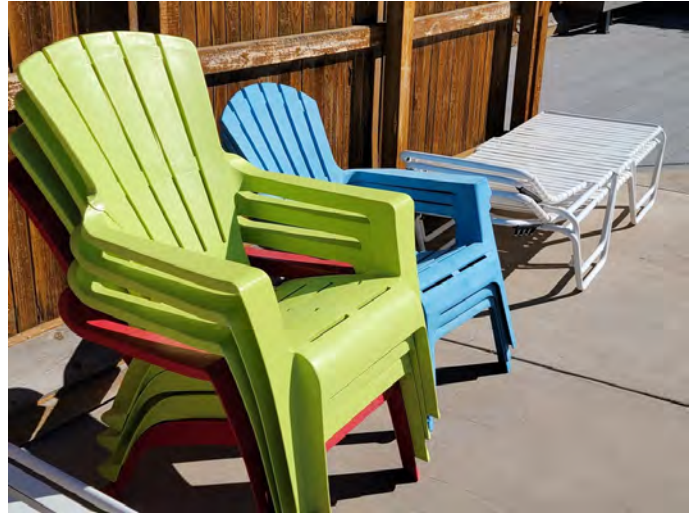
Comp #: 1121 Pool Furniture - Replace

- Due to inexpensive furniture, we recommend replacing on an as needed basis with general operating funds.

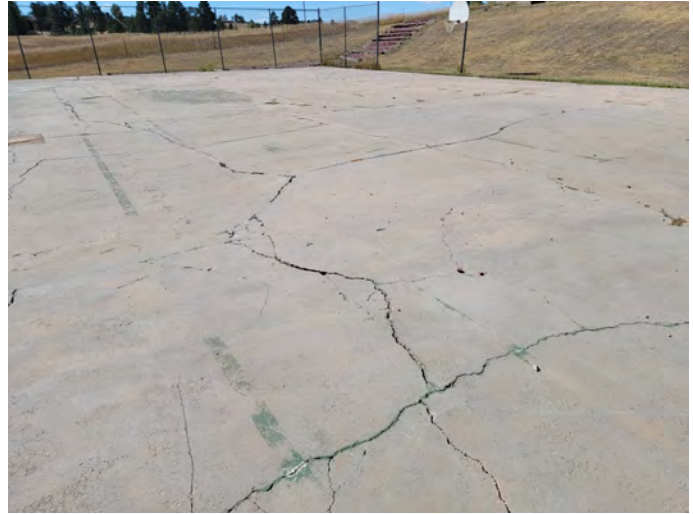
Comp #: 1201 Upper Tennis Court - Remove/Refurbish

- This court is in poor condition and needs to be addressed in some manner in the near future. To replace with a post tension court, the cost would range between \$125,000 - \$140,000. Since there are no plans to install a new tennis court with post tension at this time, we recommend establishing some funds for removal of court and regrading or other improvements to this area. The exact cost depends on the decision of the Board and the homeowners. Once a decision has been made, the cost and future life expectancies can be adjusted accordingly.

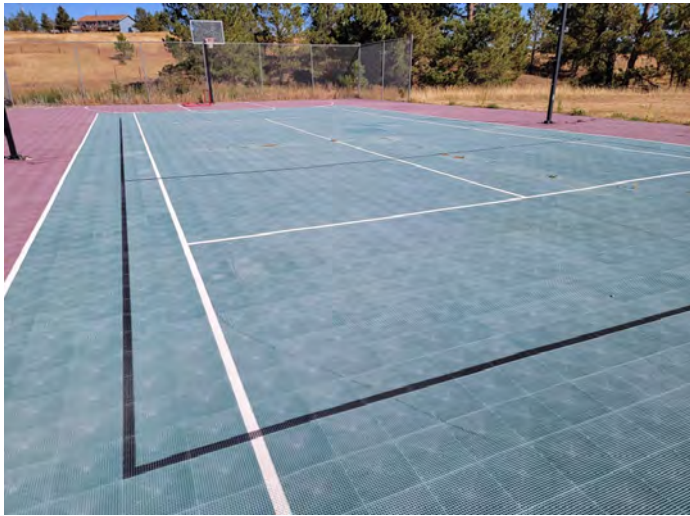
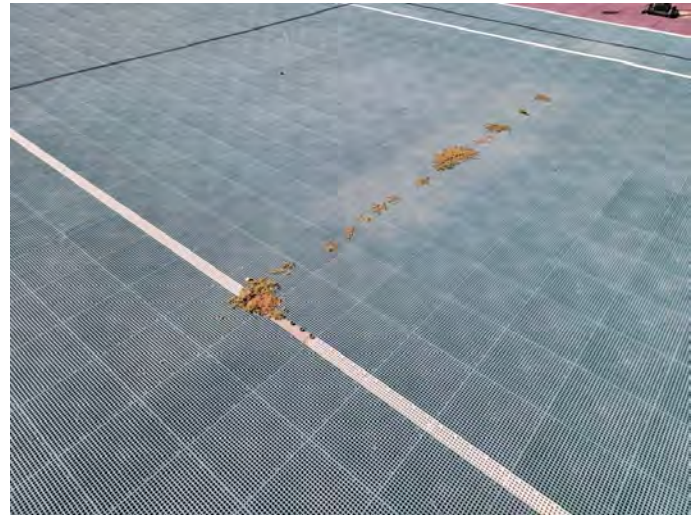
Comp #: 1204 Sport Court - Clean/Repair

- This line item is for periodic cleaning and general maintenance of the Sport Court. At the time of the site visit, we noted several areas of weeds and grass growing through the play surface, as well as a buildup of dirt and debris under the court.

- Manufacturer/installer of the court recommended that the court subsurface is inspected and cleaned every 2 - 3 years in order to maximize the useful life of the court and to ensure a level playing surface.

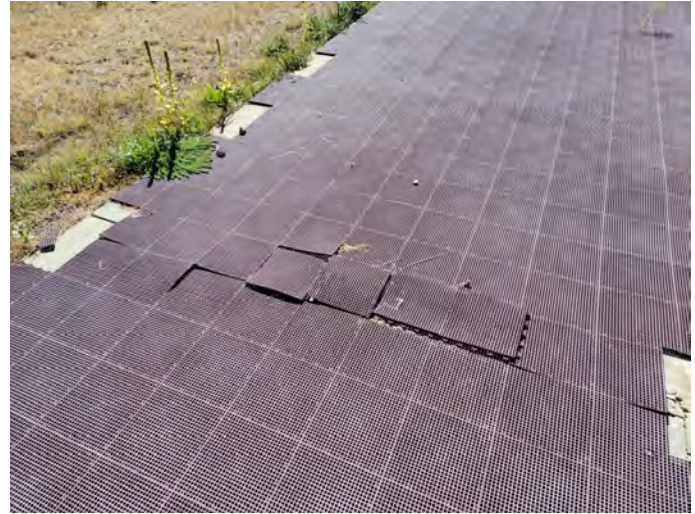
Comp #: 1204 Sport Court - Replace

- The Sport Court fair to poor condition with some loose tiles, and what appeared to be brittle materials as well. Spare parts are no longer available.
- These courts are warranted for 15 years but if properly maintained, the association can expect a life expectancy of approximately 20 - 25 years.
- With some cleaning of the base surface and repairs of broken or missing tiles, we have extended the life of the sport court by 3 years at this time.

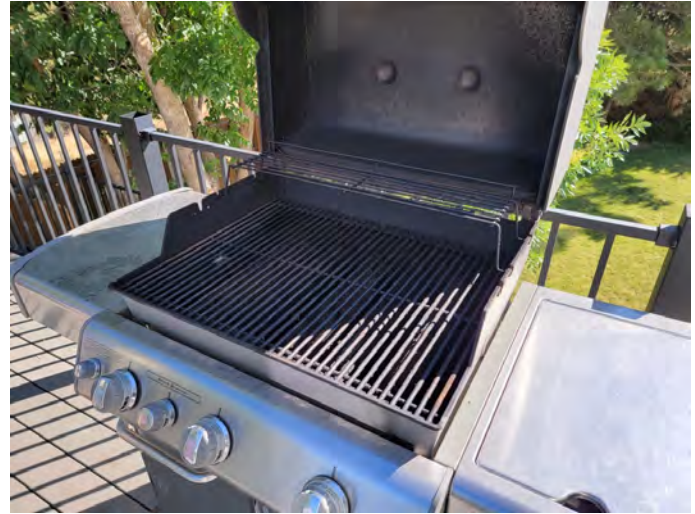
Comp #: 1305 Barbecue - Replace

- Barbecue is in good condition with no unusual signs of deterioration observed.
- On average, these barbecues have a life expectancy of 7 - 10 years. However, based on age of this unit and observed condition, we extended the replacement cycle to 12 years and adjusted the remaining life accordingly.
- Remaining life is based on age of barbecue.

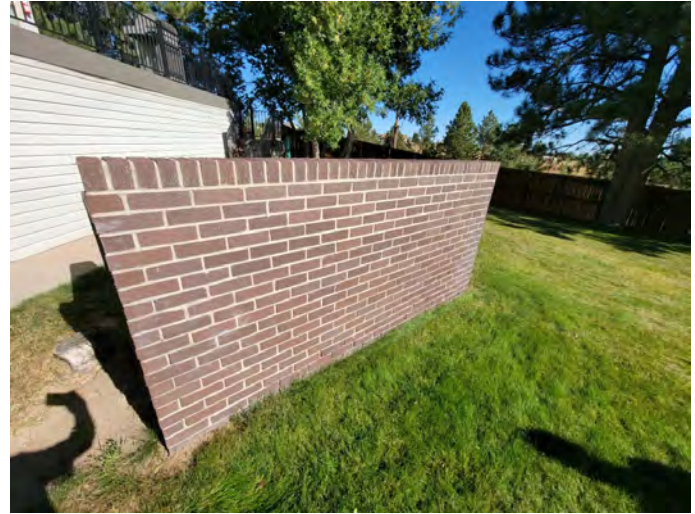
Comp #: 1305 Barbecue Pit - Replace

- Structure is very stable and in good condition. There were no observed concerns with loose or missing grout, or any broken or chipped bricks.
- At this time, based on the observed condition and the assumed age of the structure, we do not foresee the need for complete replacement or significant repairs
- We recommend performing any necessary repairs on an as needed basis using operating funds.

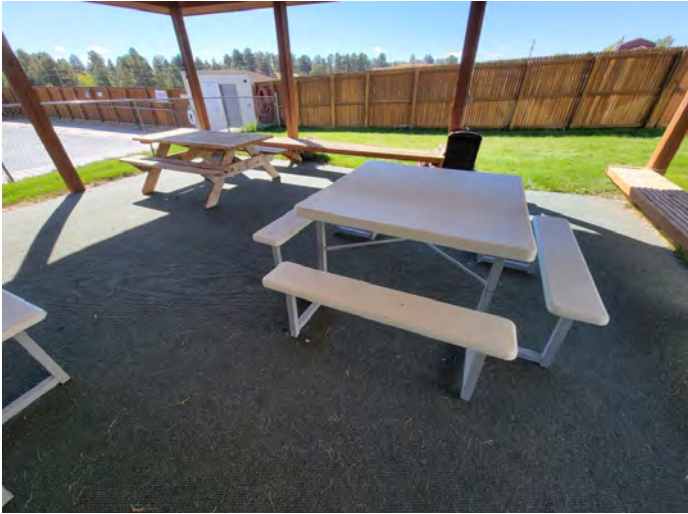
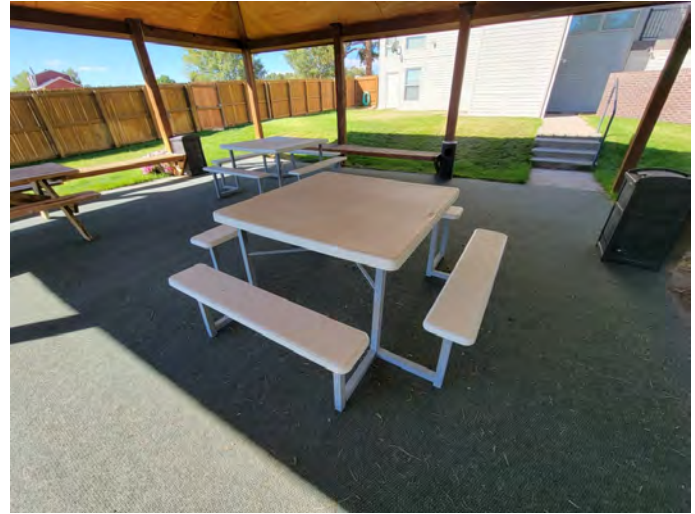
Comp #: 1306 Picnic Tables - Replace

- Based on current quality of the picnic tables, we recommend replacing as needed with general operating funds due to low replacement cost
- If the association upgrades to more commercial style tables, then Reserve funding can be added once a decision has been made to upgrade.
- At this time, Reserve funding is not required for this component.

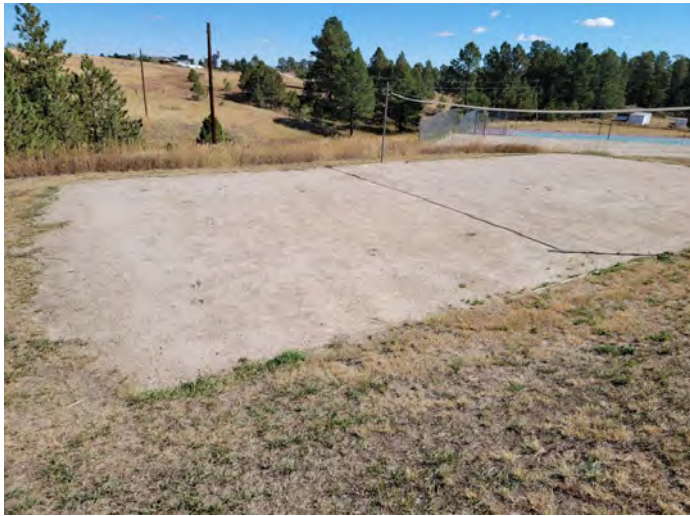
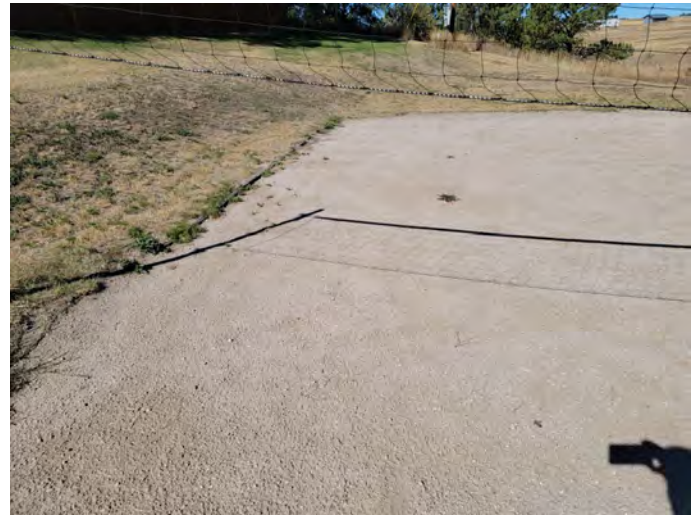
Comp #: 1315 Volleyball Court - Refurbish

- Court is currently in need of a major refurbishment project. The existing sand needs to be removed, tilled, and new sand installed to restore playable conditions.
- In addition, a net screen should be installed off to the sides of the court to prevent the ball from rolling away too far after being hit.
- Depending on the level of use, we recommend performing this work every 15 - 18 years.

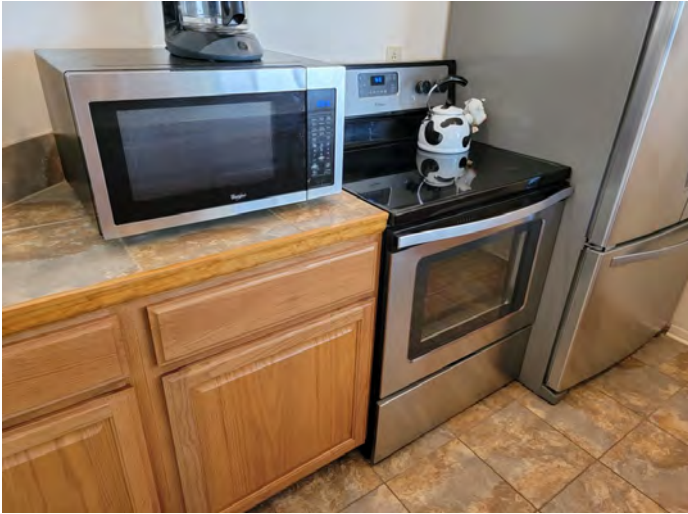
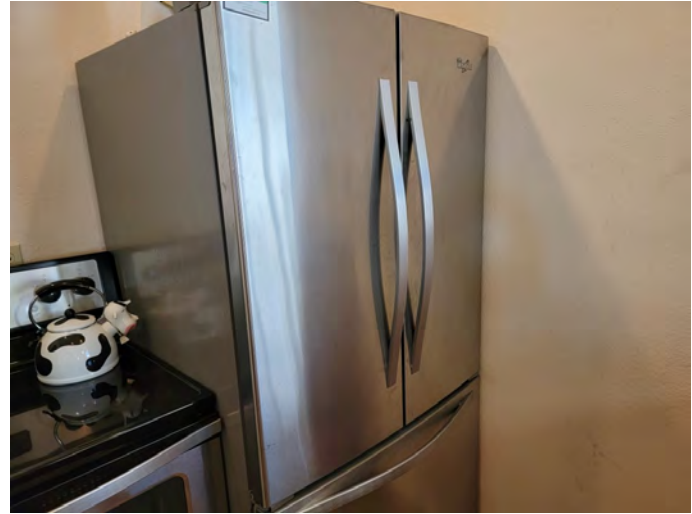
Comp #: 1402 Appliances - Replace

- Due to the minimal use these appliances receive expect a useful life of approximately 10 - 15 years from these units.
- Remaining life based on current age and condition.

Estimate to replace all appliances

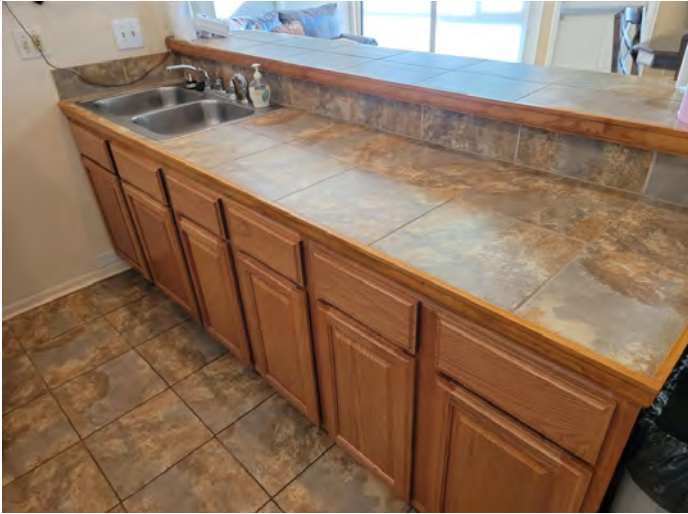
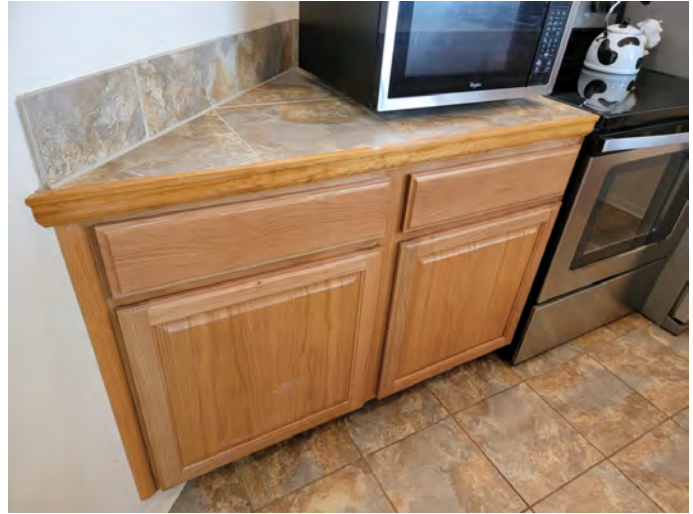
Comp #: 1403 Cabinets/Countertops - Replace

- Expect a useful life of approximately 20 years from cabinetry and countertops depending on level of use.
- The association may get a longer useful life from these components, the concern is that after a period of time they will appear dated and the desire to replace them based on appearance is likely.
- The decision of when to replace and how much to spend is ultimately up to the board of directors as this is considered a cosmetic issue.

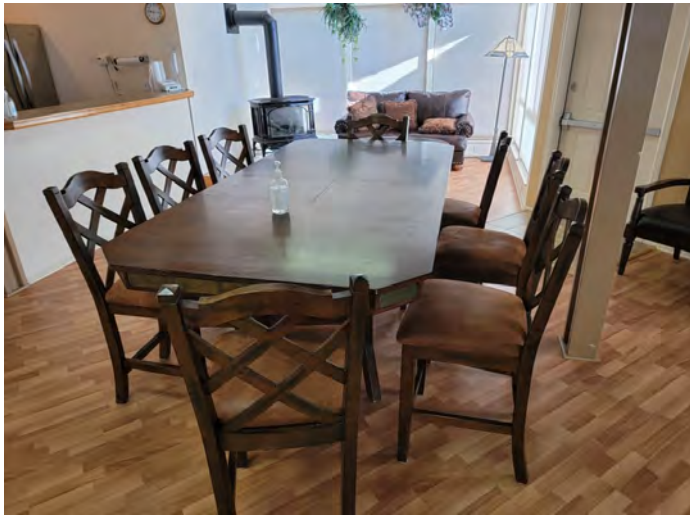
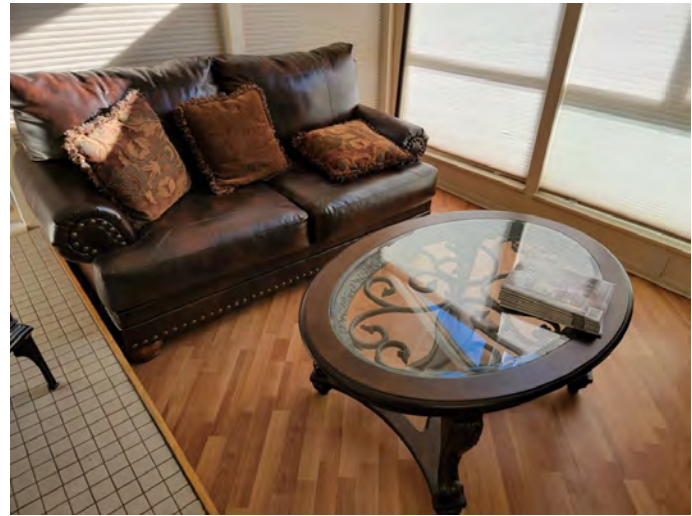
Comp #: 1405 Furnishings - Partial Replacement

- Furniture is in good condition with no unusual signs of mistreatment or abuse.
- This line item is for periodic replacement and upgrades of furniture as the Board deems necessary
- This is for partial replacement and should not be misconstrued as full replacement of all furniture.

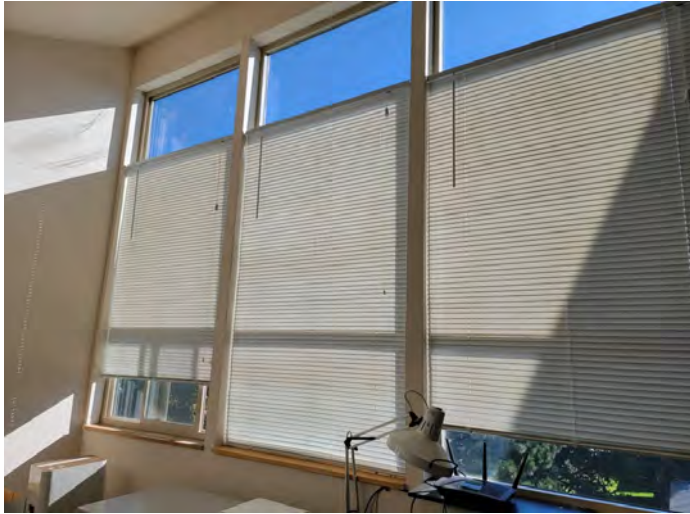
Comp #: 1408 Window Treatments - Replace

- The average life for window coverings ranges from 10 - 12 years under normal conditions.

\$200/set; Average estimate to replace

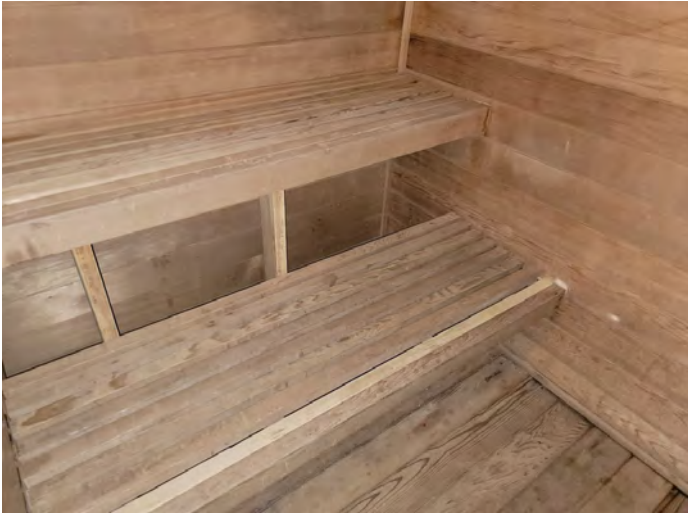
Comp #: 1409 Sauna Room - Refurbish

- Depending on the level of use and care, expect to refurbish sauna room (wood repairs, heater replacement, etc.) every 20 - 25 years.

Estimate to repair wood and replace heater
