Monday, January 24, 2022

Level 2, Premium Reserve Analysis

# Pawnee Hills Community Association

35644 Cheyenne Trail  
Elizabeth, CO. 80107

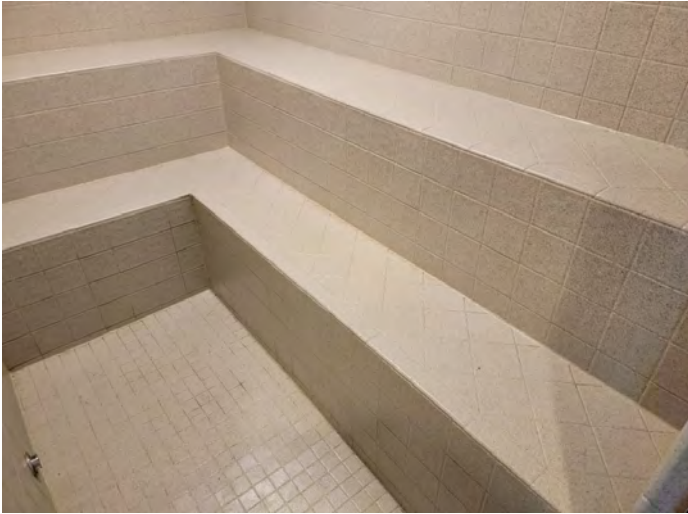
Comp #: 1411 Steam Room - Refinish/Repair

- A finish was applied over the existing tile in 2014 and is still in good condition.
- According to the contractor that performed the work, the average life expectancy for this finish ranges from 12 - 18 years, depending on the level of use the steam room receives
- Remaining life is based on current observed condition and the age of the material.

Allowance for refinish and repairs

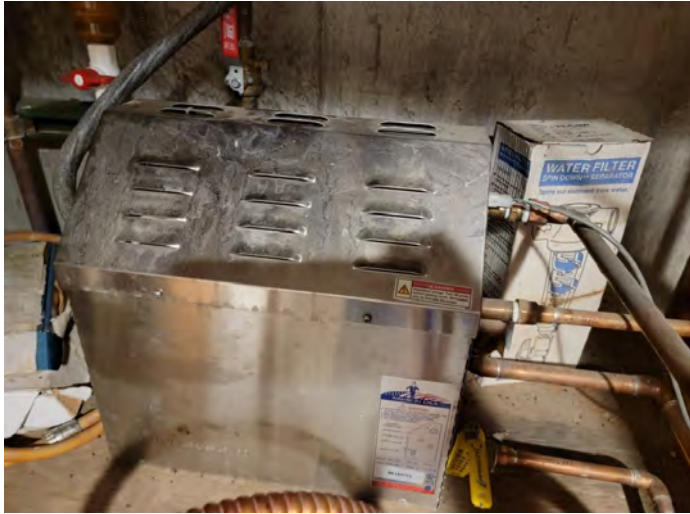
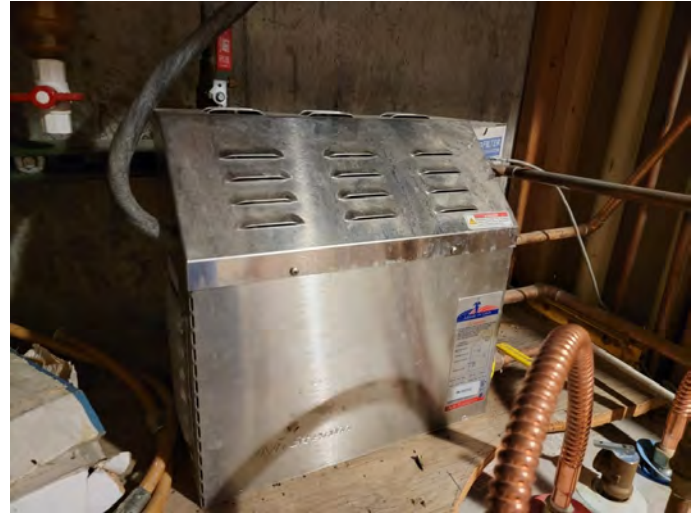
Comp #: 1412 Steamer - Replace

- No problems reported with the steam generator
- Expect to replace the steam generator every 10 - 15 years if properly used and maintained.
- Unit is older and, while still functional, the association should be prepared financially for replacement at any time in the near future.

**Mr. Steam Unit**  
**Model - MS300**  
**Serial #189702**

Estimate to replace steamer and controller

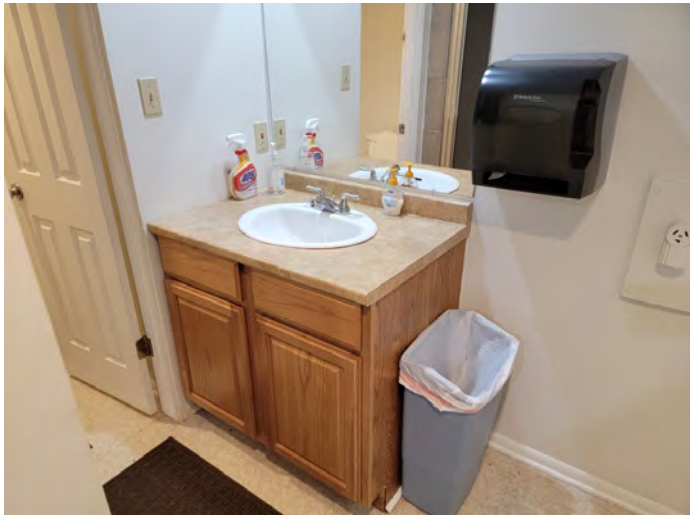
Comp #: 1413 Restroom - Remodel

- Most associations perform a general remodel of the restroom/locker room interiors every 15 - 20 years to maintain appearance and keep up with current decorative trends.
- Based on the age of the community, we suggest planning a remodel of the interiors in the near future. It was reported there is a desire to replace the flooring in the restrooms.
- The final decision is up to the community members in deciding when to spend the money to perform this project since it is considered cosmetic.

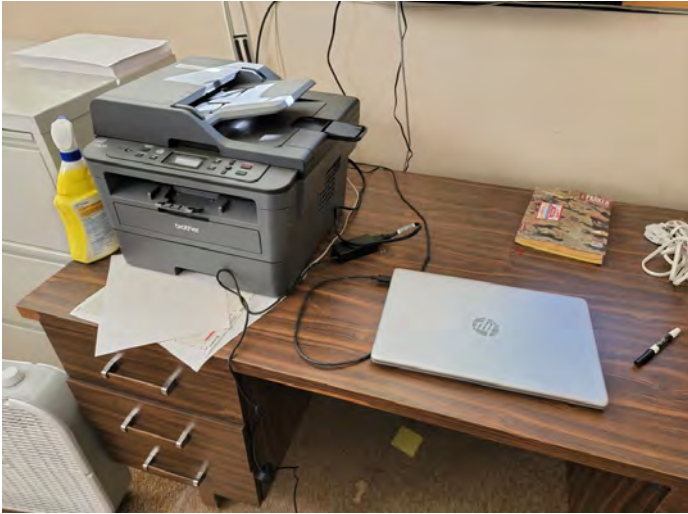
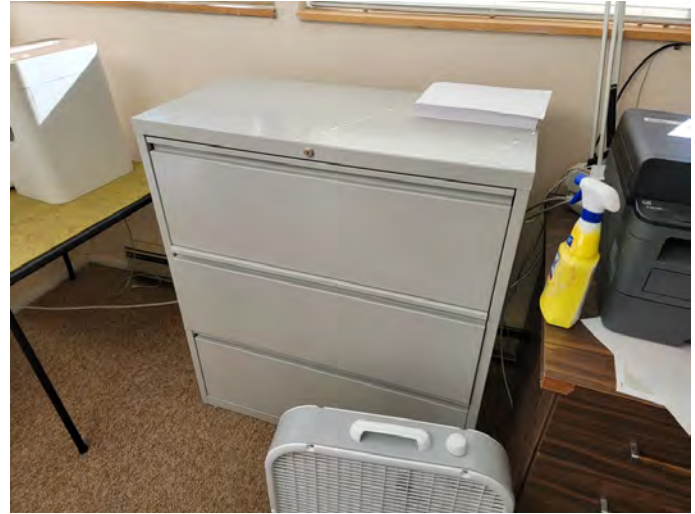
Comp #: 1417 Office Equipment - Replace

- New file cabinet and new computer/printer was recently purchased. All appear to be functional and in good condition.
- Due to changes in technology, we recommend the association plan on replacing equipment every 5 years.
- Remaining life is based on reports of recent replacement.

Allowance to replace equipment/computers

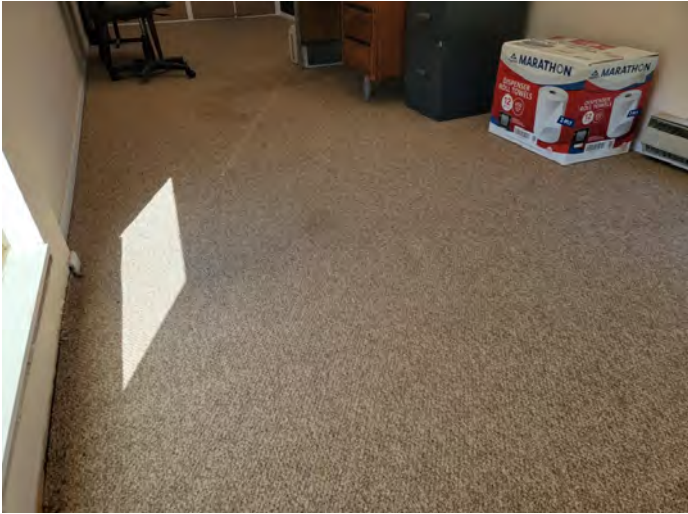
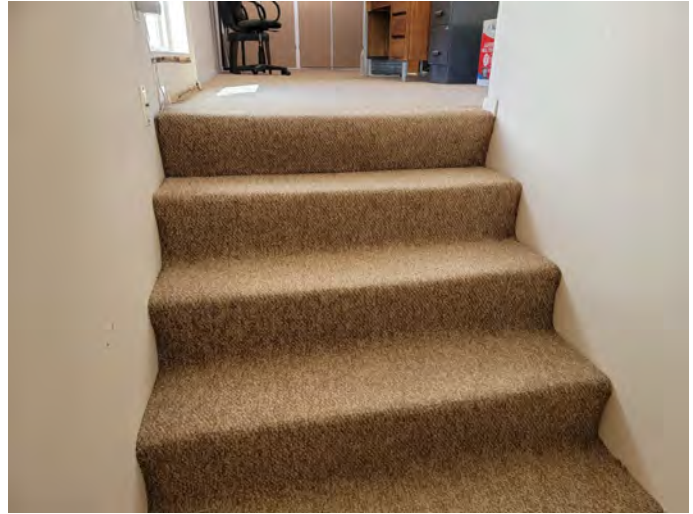
Comp #: 1501 Carpeting - Replace

- Expect to replace this component every 10 - 12 years assuming normal use and wear.
- We extended the remaining life a couple years to redo carpeting and tile at the same time for best cost estimate and to match the décor

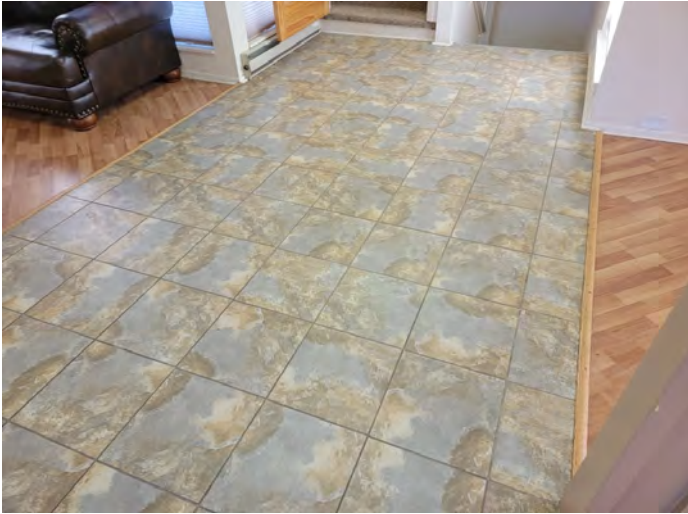
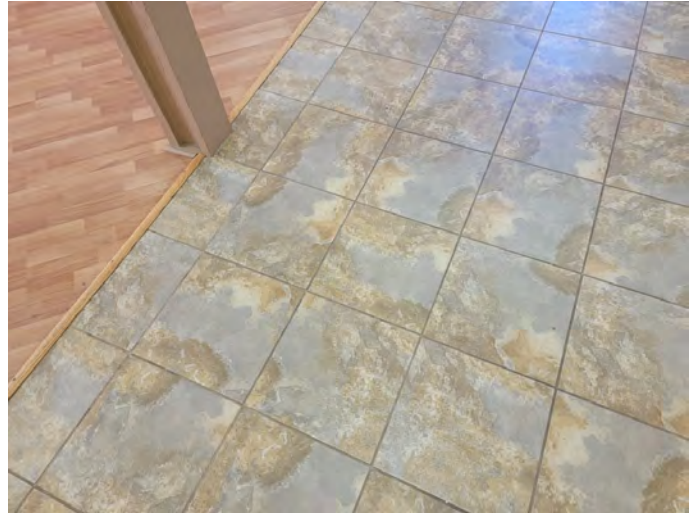
Comp #: 1503 Porcelain Tile - Replace

- Depending on the quality of tile, the level of use and care, the average life expectancy of ceramic tile ranges between 20 - 25 years.
- Coordinate with other interior projects to match décor and get best cost estimate possible.

\$17/GSF: Estimate to replace

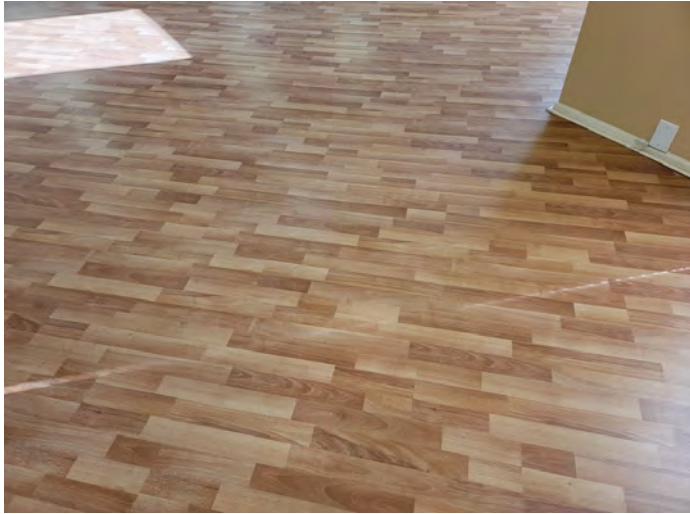
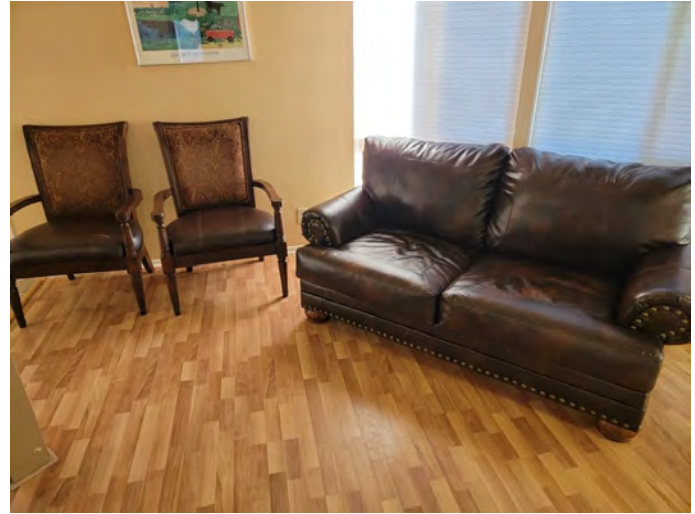
Comp #: 1505 Laminate - Replace

- Depending on the level of use, this type of flooring will have a life expectancy of 15 - 20 years.
- Oftentimes, laminate flooring may appear dated over time, but this flooring has an appearance that can have an extended life.
- At this time, we recommend establishing a replacement cycle of 20 years, but actual replacement will depend on the boards decision for changing the style since it is likely the flooring will outlast the trend.

Best Cost: **\$17,325**  
\$12.50/GSF; Estimate to replace

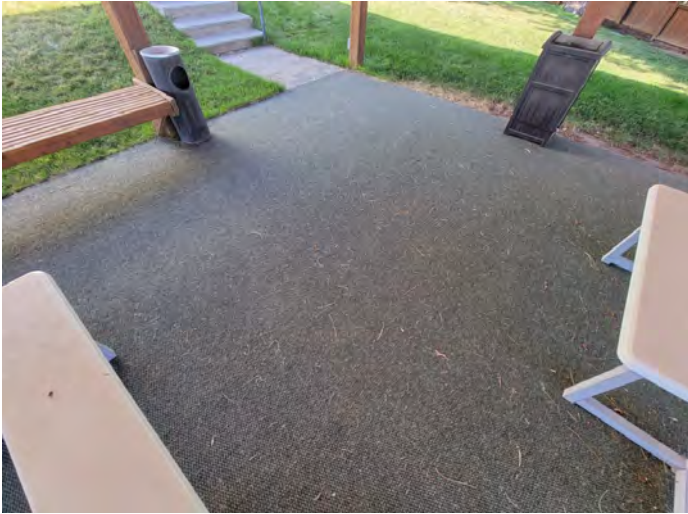
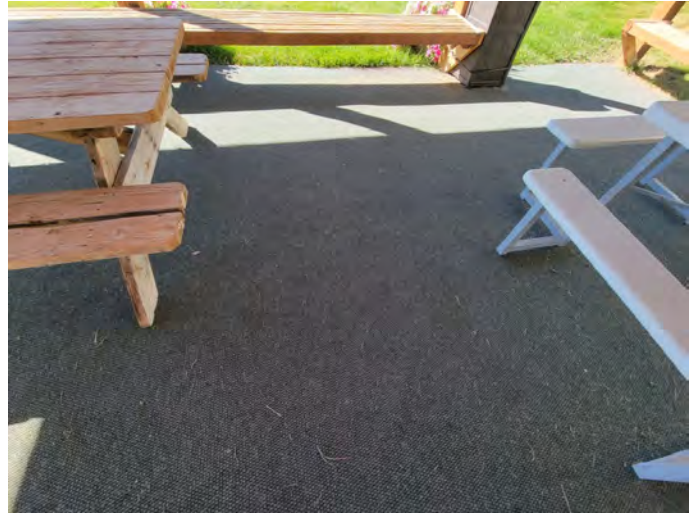
Comp #: 1507 Indoor/Outdoor Carpet - Replace

- This carpet was replaced in 2013 and is still in fair condition at the time of site evaluation.
- Expect to replace indoor/outdoor carpet every 8 - 10 years to maintain appearance and function.
- We extended the life expectancy to 12 years based on age and observed condition.

*Best Cost:* **\$1,500**  
\$15/GSY; Estimate to replace

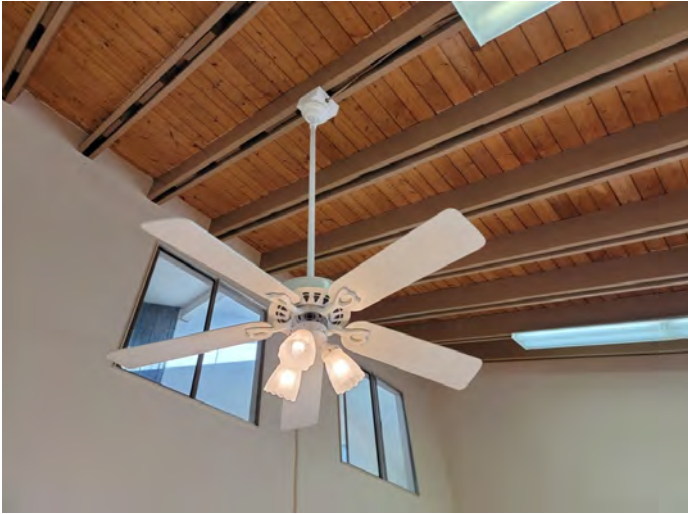
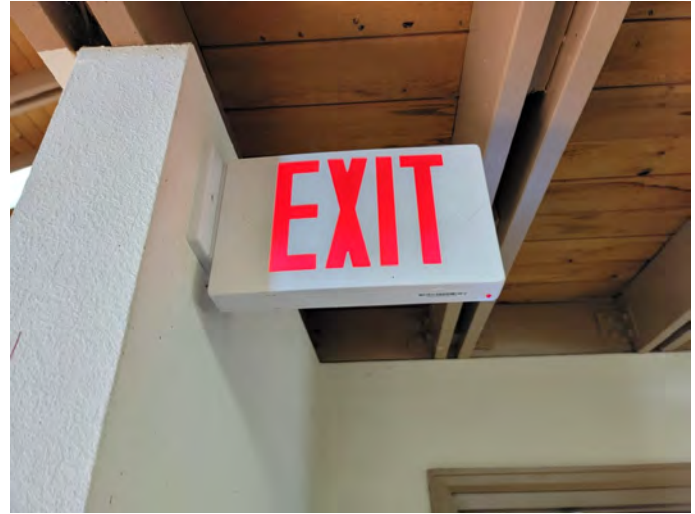
Comp #: 1601 Interior - Replace

- New exit signs purchased and installed by on site maintenance staff in 2020.
- Due to the low replacement cost of these type of lights, we suggest replacing on an as needed basis with general operating funds.
- Also, the majority of these lights are not considered decorative, and replacement can occur without disrupting the décor of the room.
- Therefore, at this time, separate Reserve funding is not required for this component

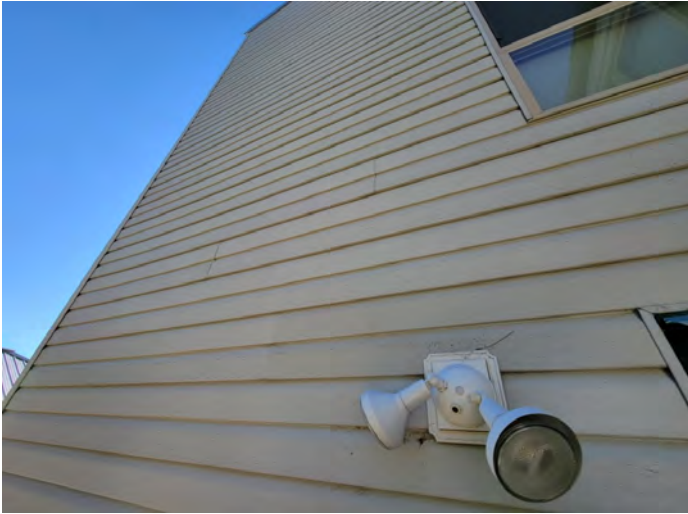
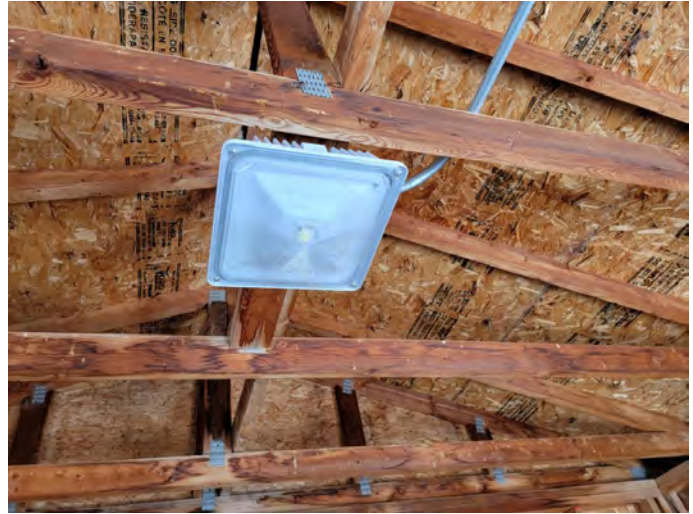
Comp #: 1602 Exterior Lights - Replace

- Due to the minimal cost to replace these lights, Reserve funding is not appropriate.
- Repair and replace as necessary as an operating expense.

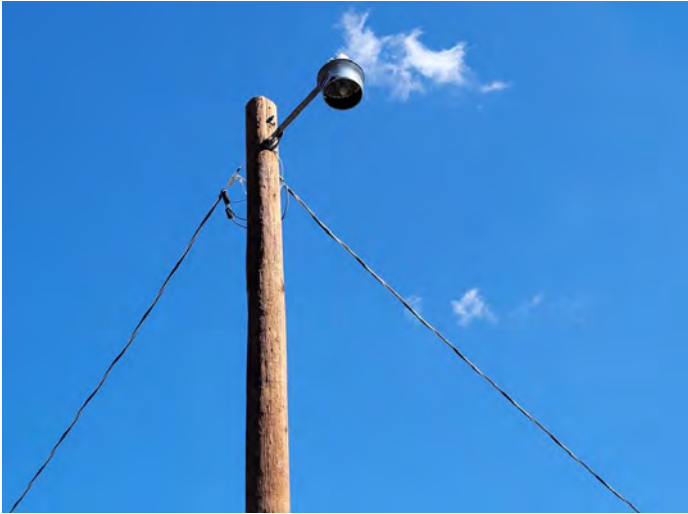
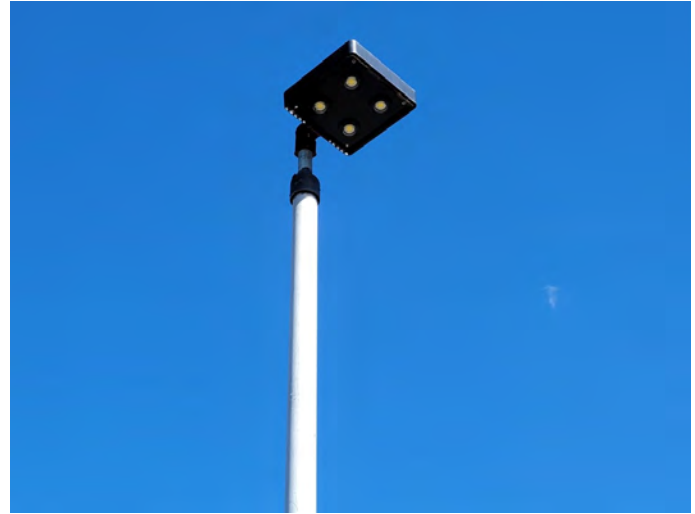
Comp #: 1604 Pole Lights - Replace

- New LED lights were installed at the pool and the parking lot. Most of the fixtures at the arena have been replaced as well.
- The average replacement cycle for these lights should range from 10 - 15 years for the fixture head
- Remaining life is based on when the fixtures were replaced.

Best Cost: **\$6,400**  
\$800/fixture; Estimate to replace

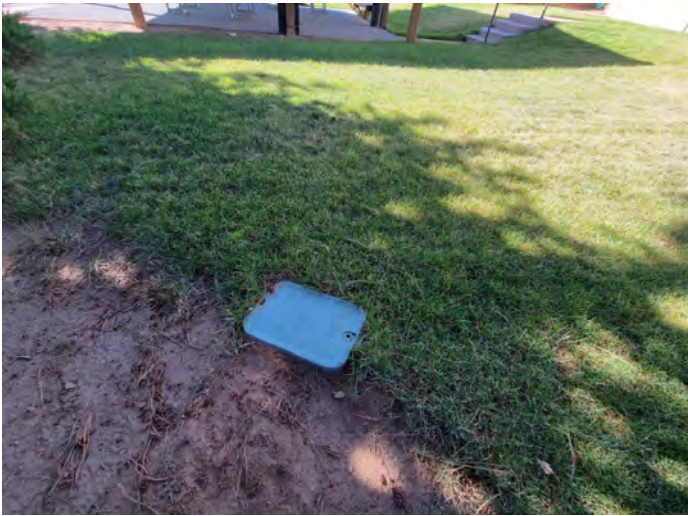
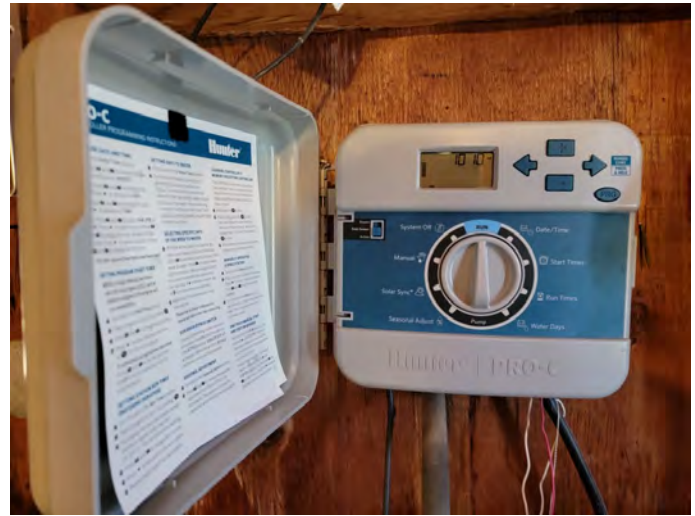
Comp #: 1701 Irrigation System - Major Repairs

- System is small and there have been no reported problems with the system.
- At this time, there is no expectancy to completely replace the system and Reserve funding is not recommended.
- We recommend the association establish a line item in the general operating budget for annual repairs to necessary components of the system (broken lines, sprinkler heads, controller, valves, backflow preventers, etc).

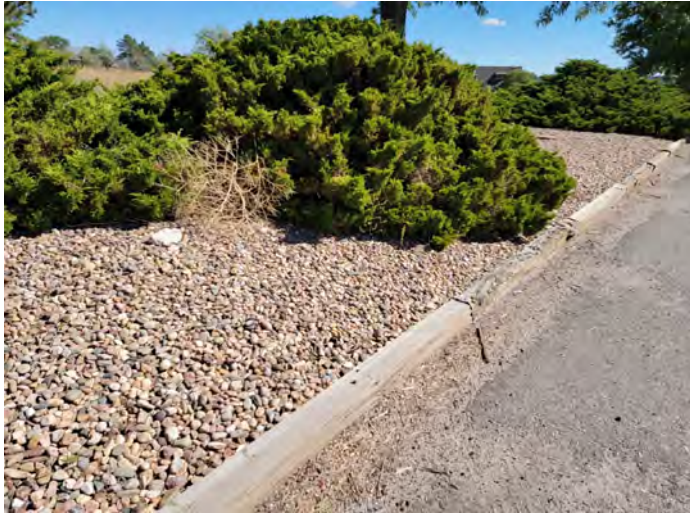
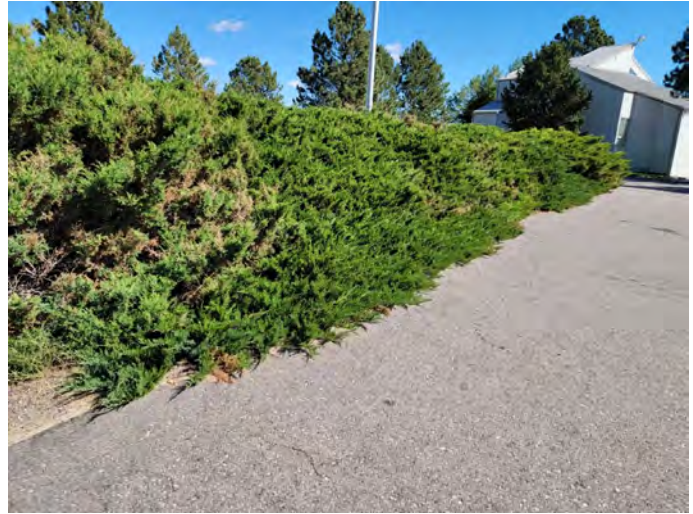
Comp #: 1801 Groundcover - Replenish

- It was reported there is interest in redoing the entry area by the mailboxes.
- This line item is for projects that lie outside the scope of routine maintenance.
- In order to preserve an attractive curb appeal and to maintain the health of the plants and shrubs, we recommend reserving for refurbishment projects every 10 - 12 years.
- This line item is for cyclical major refurbishment and should not be considered as complete landscaping replacement.
- Minor refurbishment should be handled as needed with operating funds

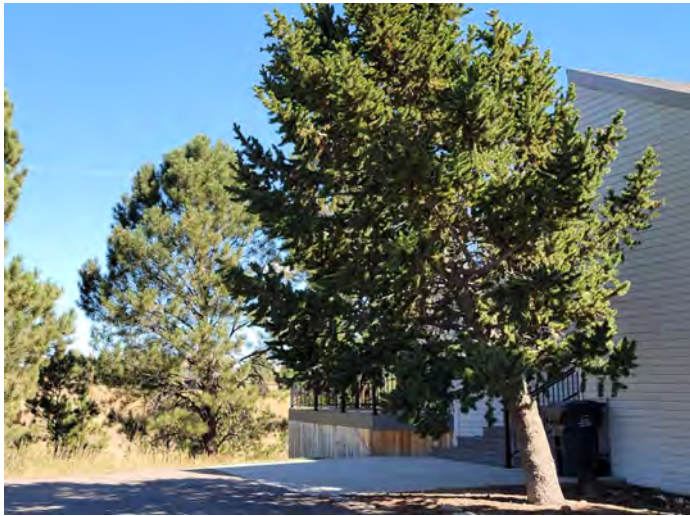
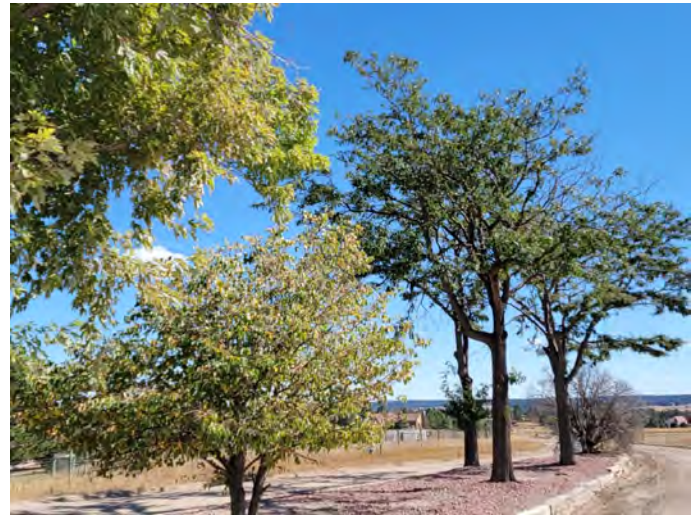
Comp #: 1804 Tree - Replacement/Major Maintenance

- Trees appeared to be healthy and in good condition at time of site evaluation.
- It is very difficult to predict a replacement cycle for trees as there are several factors such as disease, infestation of insects, heavy snow storms, etc. can all attribute to eventual tree replacement.
- Since it is difficult to predict when the replacement will be necessary, Reserve funding is typically not a factor.
- Therefore, unless requested by the association, Reserve funding will not be included as part of the study for this component.

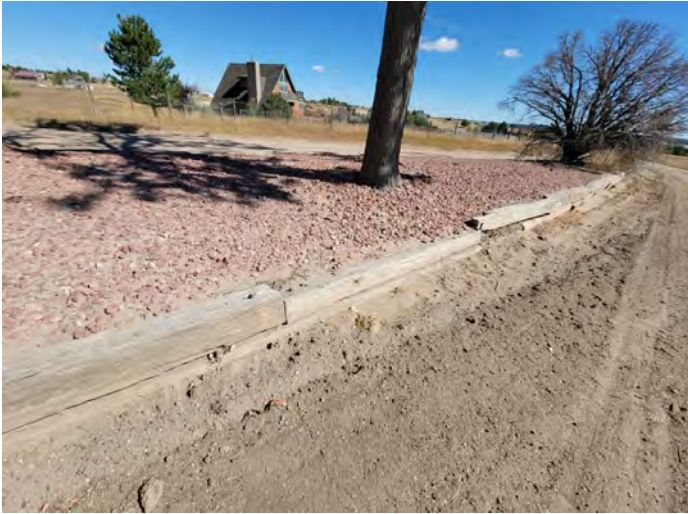
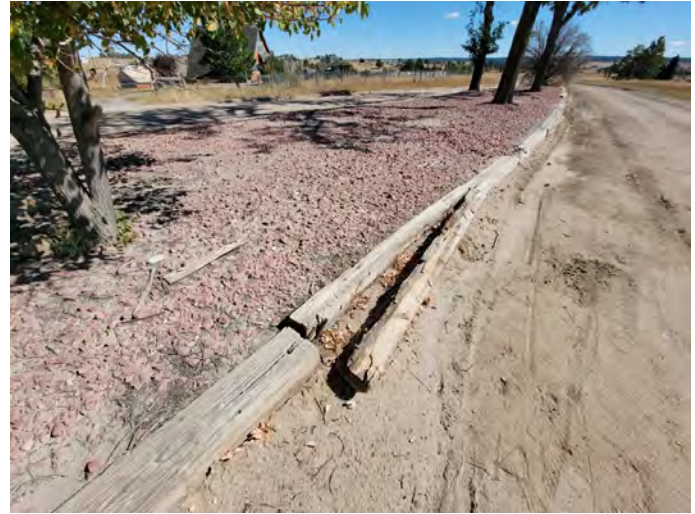
Comp #: 1805 Landscape Timbers - Major Repairs

- Several timbers are rotted out or leaning. The area around the mailbox center will be refurbished soon, and the railroad ties will be included in this project.
- We recommend establishing Reserve funds for periodic replacement of timbers every 6 years.
- This is not intended as complete replacement of all timbers, just an allowance for periodic repairs.

Allowance for major repairs

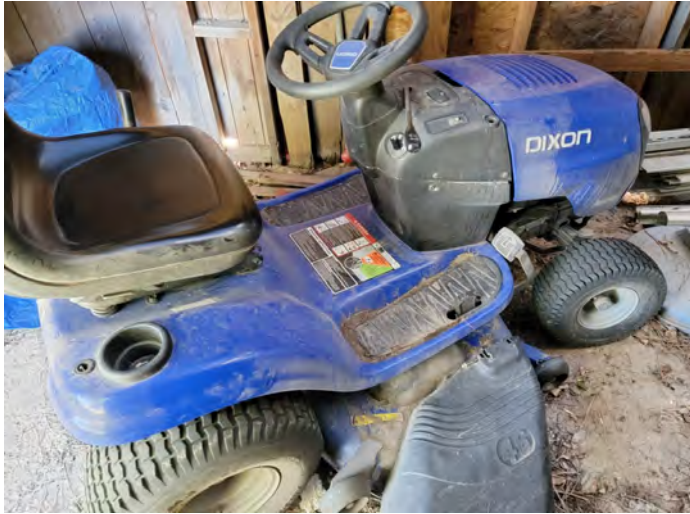
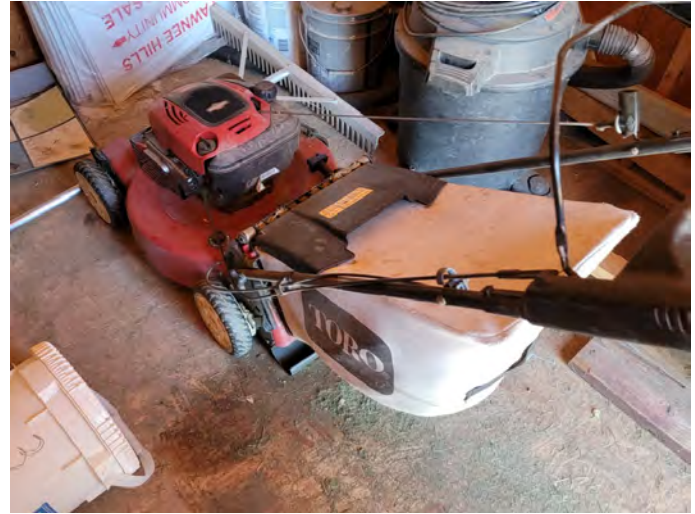
Comp #: 1901 Maintenance Equipment - Replace Allowance

- It was reported the riding mower and weed trimmer is in need of replacement. The push mower was recently serviced and is working well.
- This line item is an allowance to replace the needed equipment every 5 years.

Best Cost: **\$2,750**  
Estimate to replace needed equipment

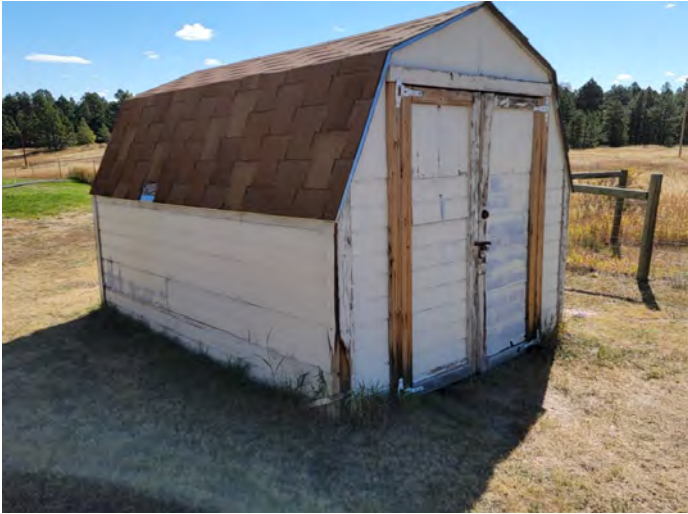
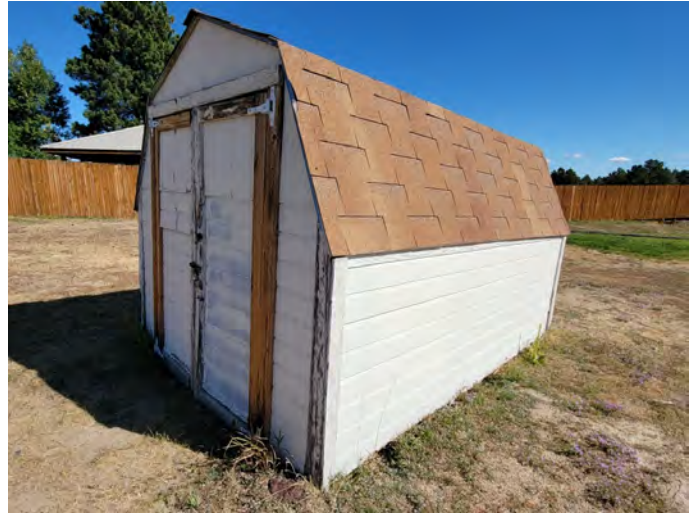
Comp #: 2001 Storage Shed - Replace

- Shed exhibits deteriorated wood and a roof that is in poor condition
- Based on age of shed and observed conditions, we recommend the association have funds available for when replacement is necessary.

Estimate to replace with similar size

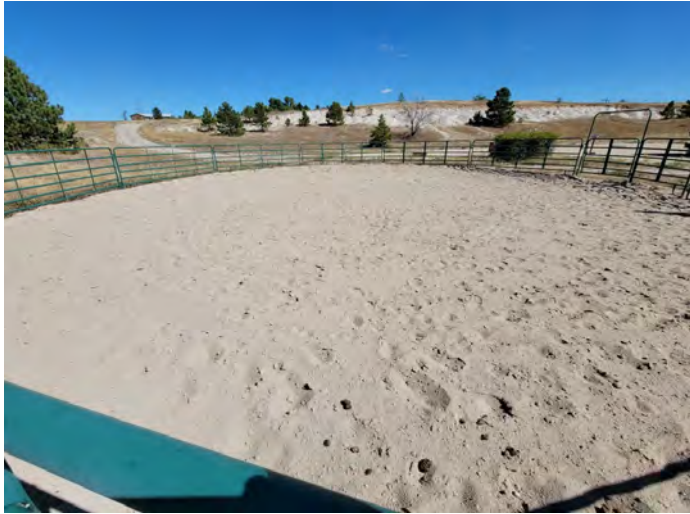
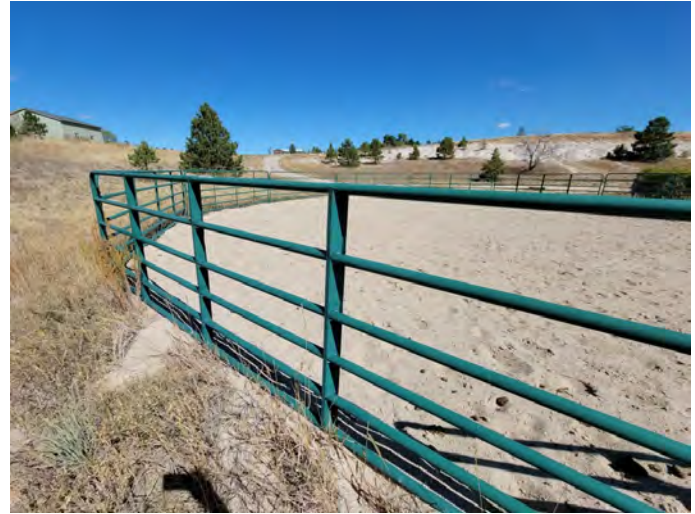
Comp #: 2030 Arena - Rebuild

- Arena was completely rebuilt in 2016 and is in good condition. No unusual conditions were noted, except a little rusting on the arena panels
- Reserve for complete rebuilding of arena every 30 years based on when the last project was completed and age of community
- In between major rebuilding, treat periodic repairs and new bedding as needed with operating funds.

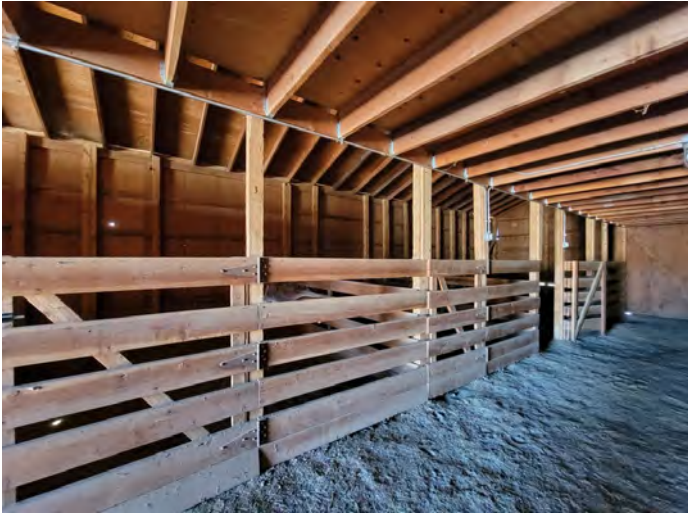
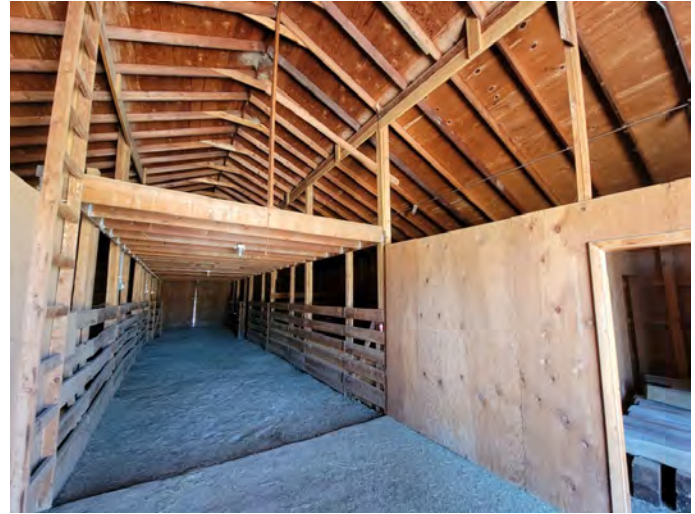
Comp #: 2035 Barn Interior - Remodel

- New electrical GFI's were installed, as well as covered lights, and replaced with LED bulbs recently.
- These projects were completed with operating funds
- All future maintenance to the interior of the barn should be performed as needed with operating funds.

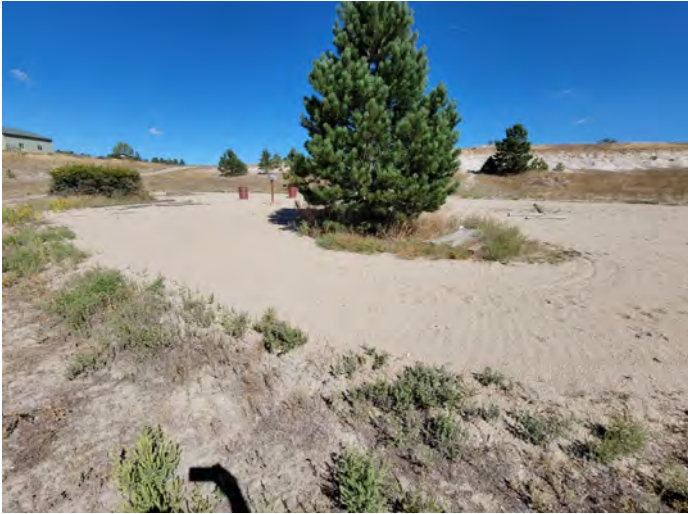
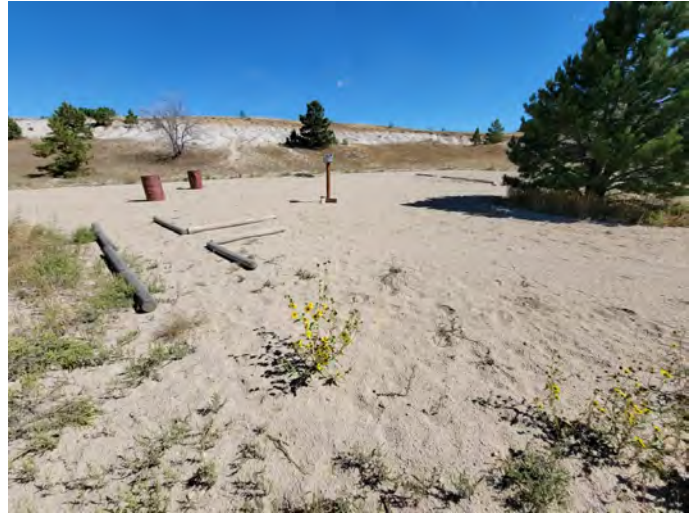
Comp #: 2035 Horse Exercise Pen - Replace

- It was reported at time of observation that the existing exercise pen was installed in 2013 and is still in good shape with no unusual conditions noted.
- Expect to replace this pen and upgrade every 18 - 20 years if properly maintained and under normal conditions.

*Best Cost:* **\$1,800**  
Estimate to replace with similar
